INSTRUMENT CLUSTER LCD DISPLAY FIX FOR MERCEDES W210 MY 2000, ALSO APPLICABLE TO W202, W208 AND OTHER MODELS

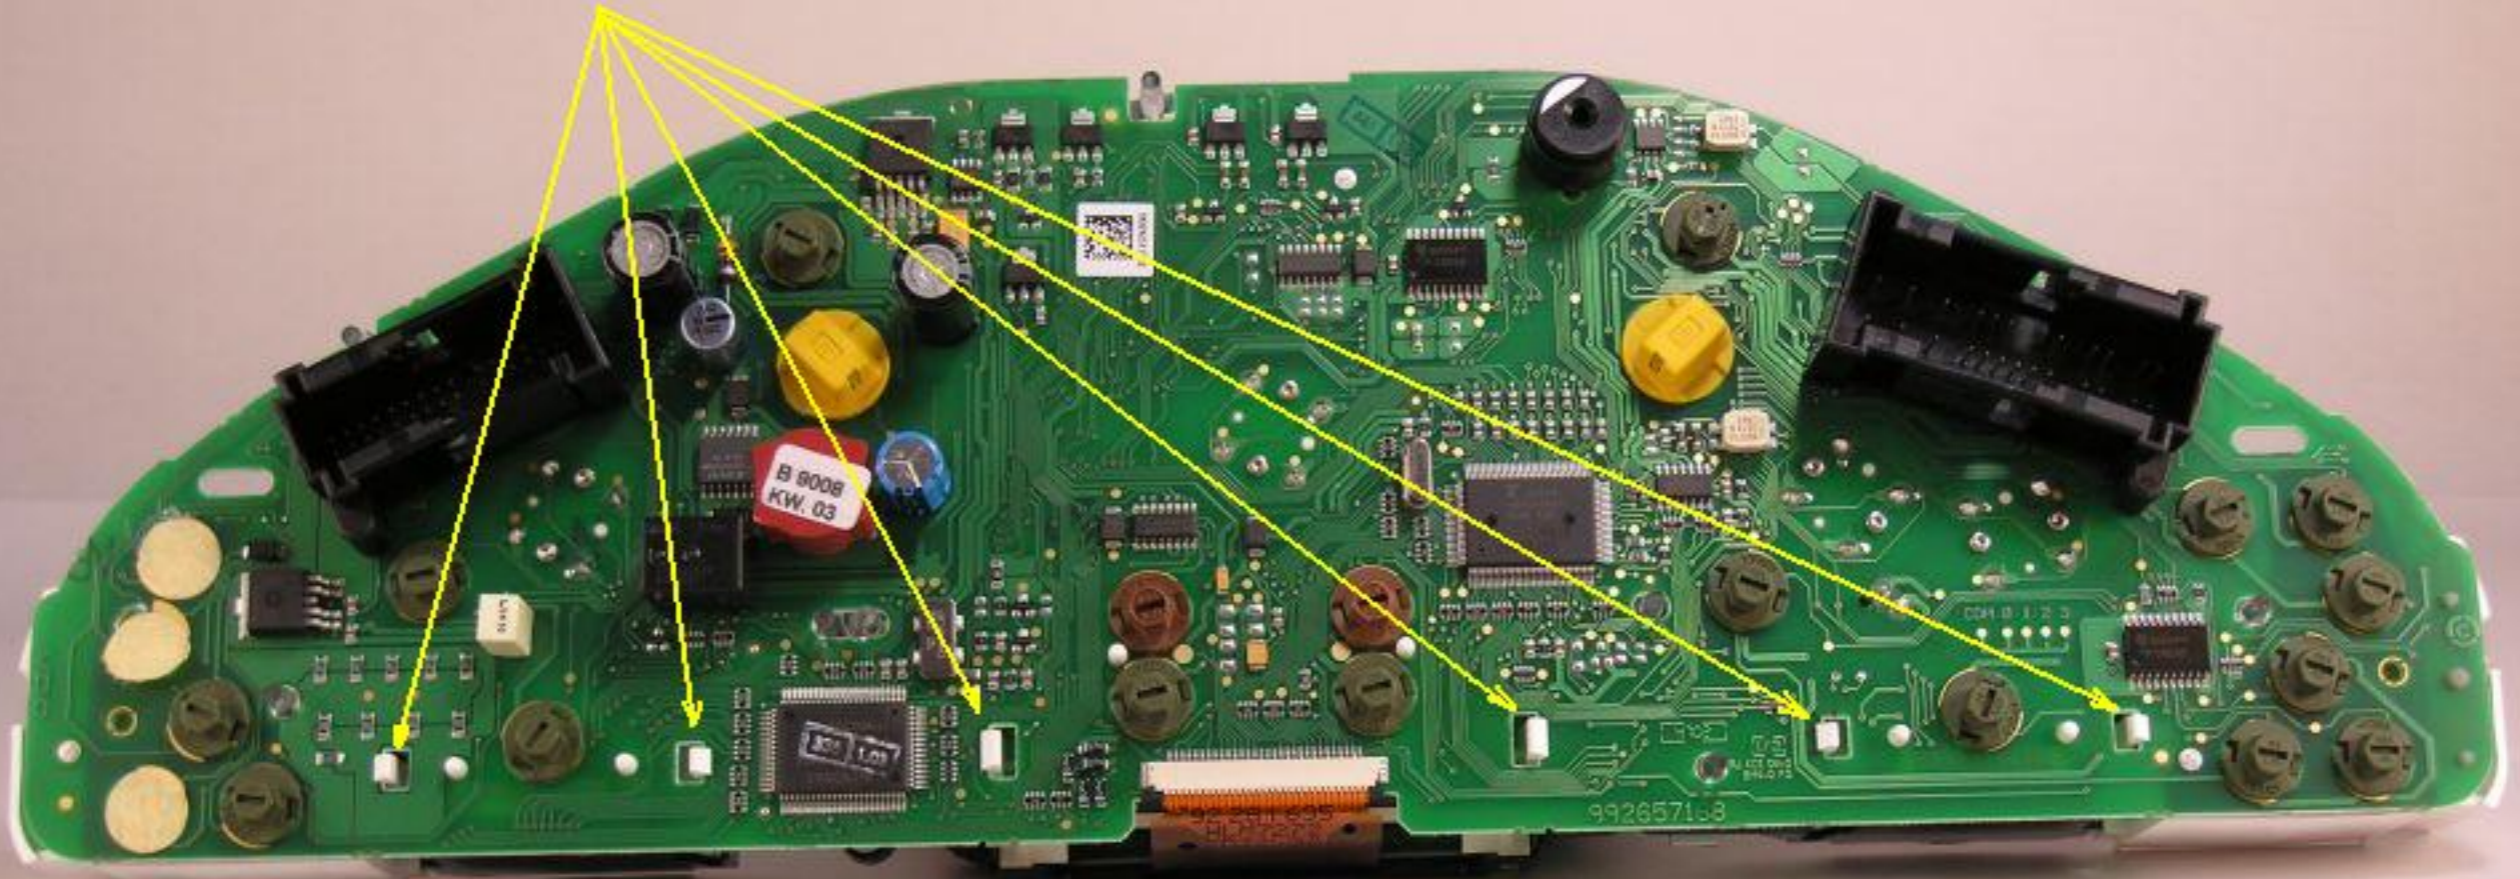
**THIS IS AN EXTREME CASE OF CONTACT SEPARATION
THAT HAPPENED DURING ONE OF THE FIRST
ATTEMPTS MADE.**

**AS A RESULT THE CLOCK WAS COMPLETELY BLACKED
OUT. WHAT A MESS!**

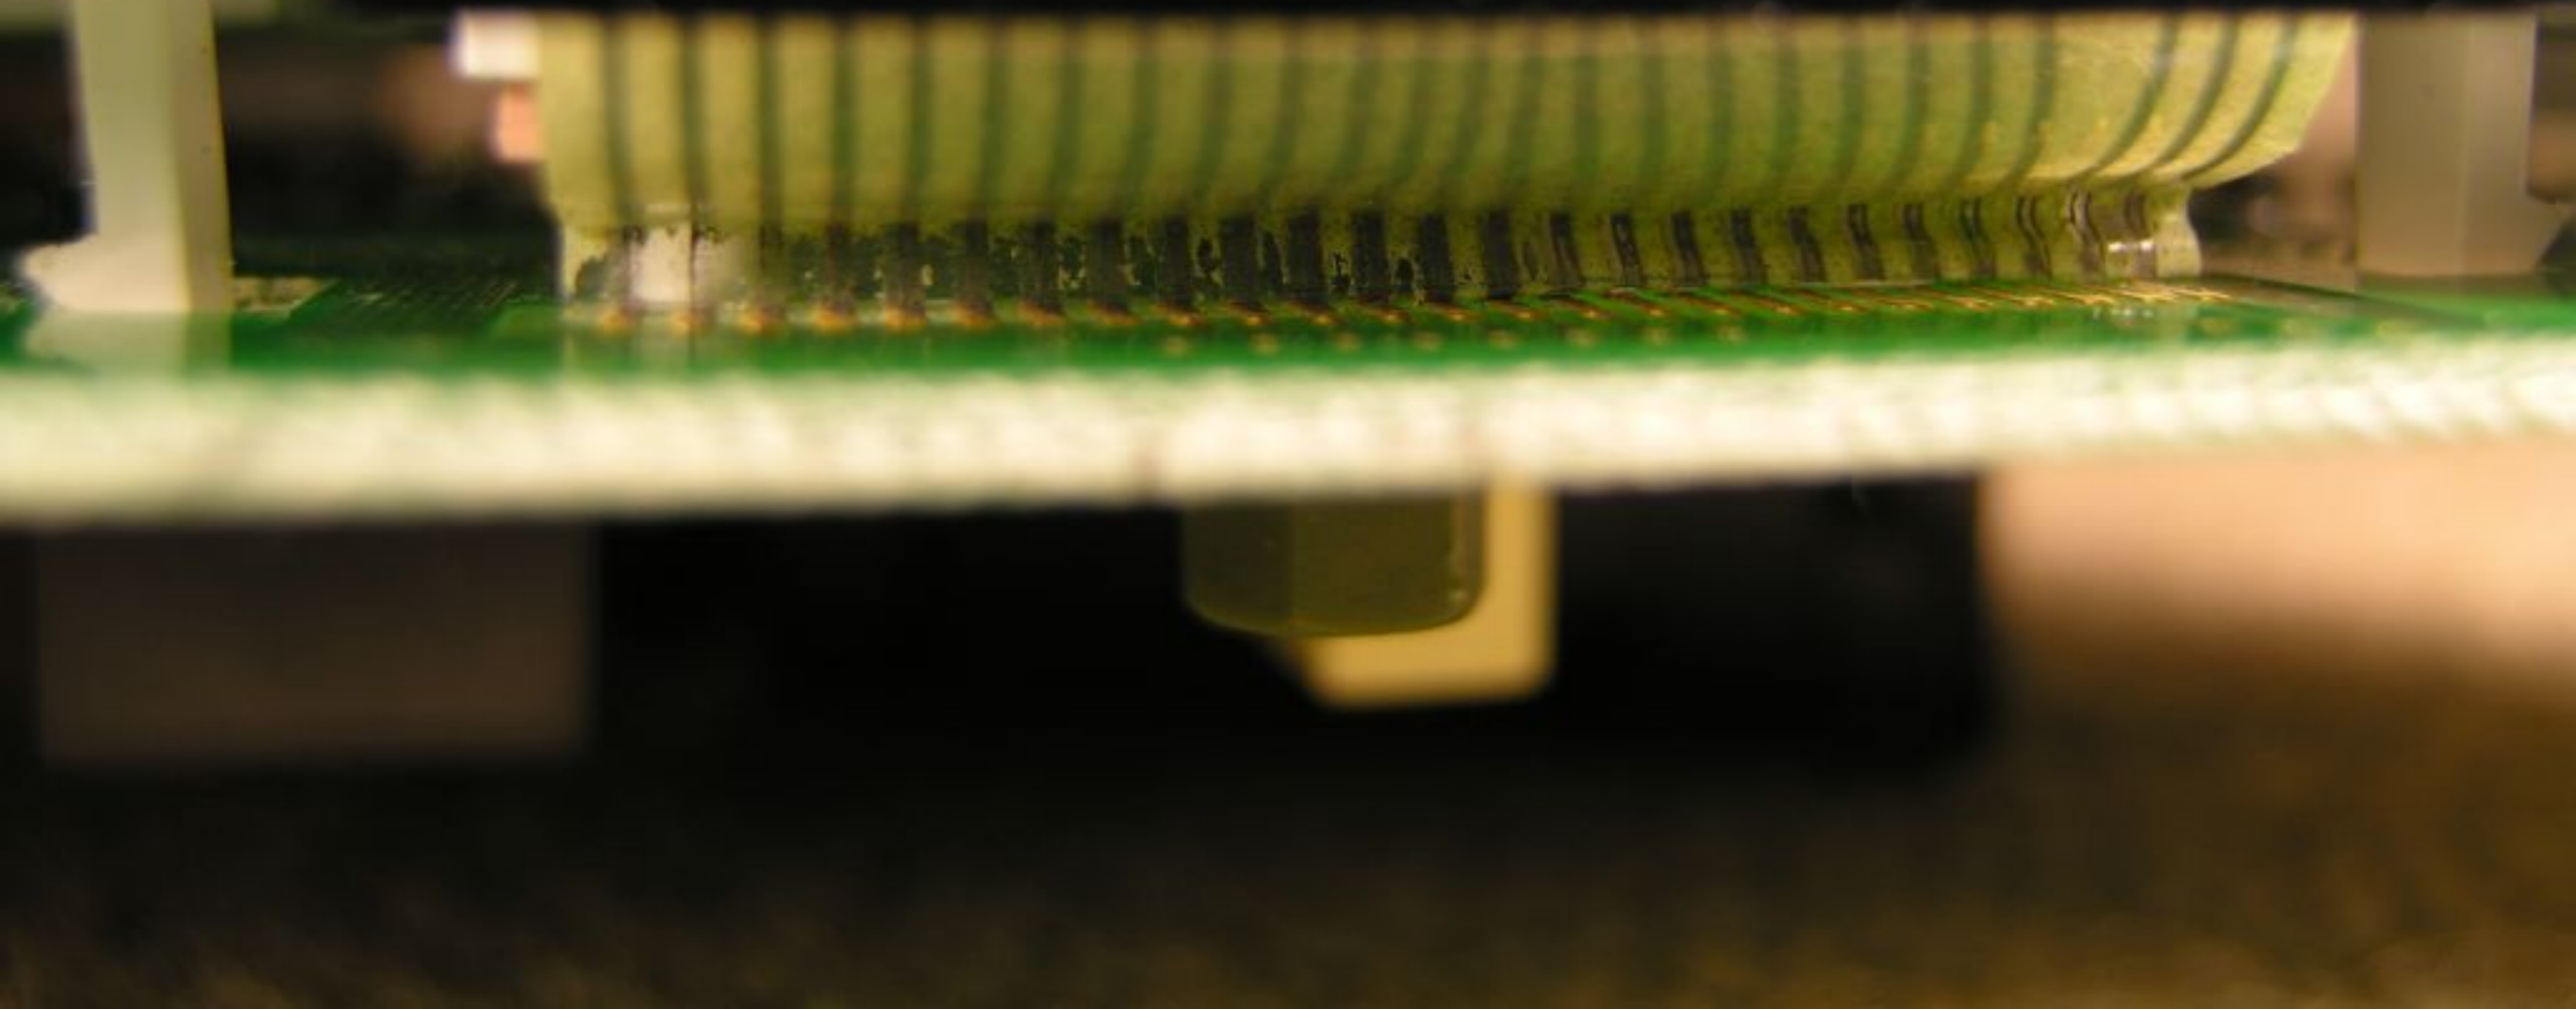
**CLOCK/GEAR SELECTOR
DISPLAY**

**NOTE THE PINK FOAM PAD THAT RUNS THE FULL
WIDTH OF THE RIBBON CABLE.**

**WE NEED TO SHIM UNDER THE PINK FOAM PRESSURE
PAD AND THE RIBBON CABLE.**

**THIS WILL CREATE ENOUGH PRESSURE TO
REESTABLISH ELECTRICAL CONTACT AGAIN.**
