SB-10052449-1693

HVIL Connector Upgrade

Classification	Repair Bulletin	Section/Group	44 - High Voltage System	Country/Region	North America, Europe
Year	2012-2013	Model	Model S	Version	All

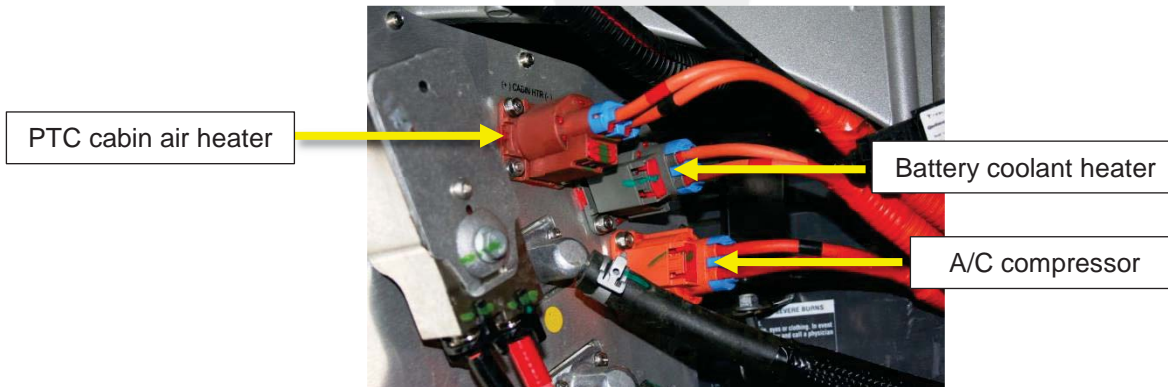
Figure 3

2. Remove the RHF upper wheel arch liner (refer to Service Manual procedure 12010902).
3. Remove the RHF lower wheel arch liner (refer to Service Manual procedure 12011302).
4. The DCDC Converter is mounted on the RHF side fender well. Locate the PTC cabin air heater, battery coolant heater, and A/C compressor connectors on the DCDC converter (Figure 3).
