2012 - 2014 RAV4 EV - Communication Problems - Gateway ECU

RAV4 EV

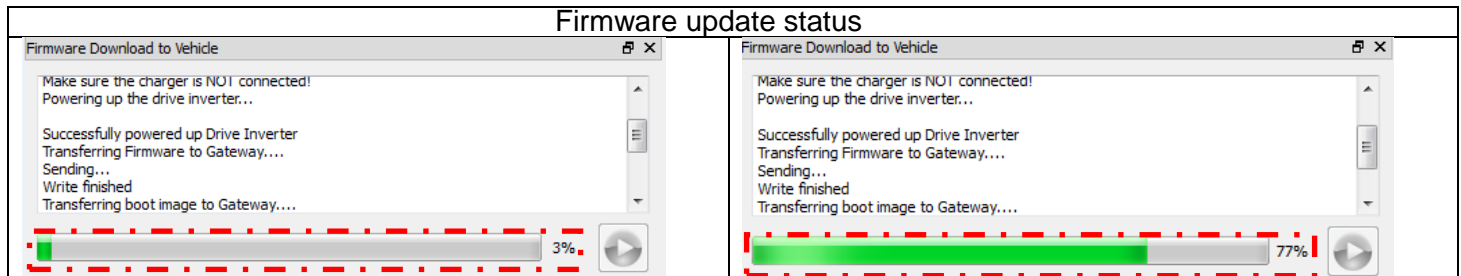
Case 2: Failure of component firmware update

Identifying the percentage (%) completion state when the update fails may help in determining the problem area. Use the following table for problem diagnostic items to attempt before replacing the gateway ECU.
