EV System Software Update

Service Category Engine/Hybrid System

YEAR(S)	MODEL(S)	ADDITIONAL INFORMATION
2012 – 2014	RAV4 EV

The information contained in this bulletin supersedes SB No. T-SB-0050-13.

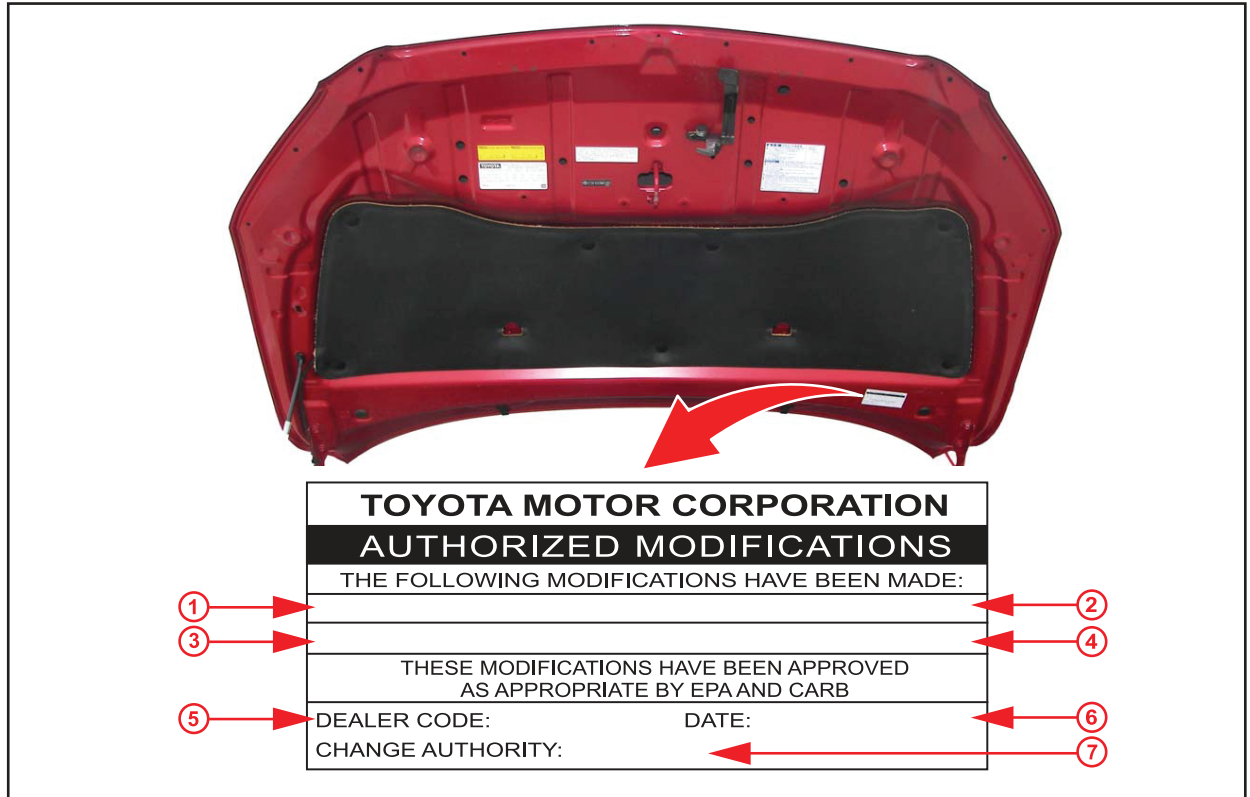
Figure 1. Location of Authorized Modifications Label on 2012 – 2014 RAV4 EV

1	Replacement Power Management Control ECU Part Number (i.e., 89690-42015)
2	Replacement EV Gateway Control ECU Part Number (i.e., 89881-0R011)
3	New Calibration ID of Power Management Control ECU (i.e., 896B34201500)
4	New Calibration ID of EV Gateway Control ECU (i.e., 1.3.83)

5	Dealer Code
6	Date Completed
7	This SB Number

1. Check for the Authorized Modifications Label affixed to the vehicle in the location shown in Figure 1. Confirm if the ECU calibrations have been updated. If the calibration IDs listed are NOT the latest ECU calibrations — go to step 2.

- Install the Authorized Modifications Label.
 - Using a permanent marker, enter the following information on the label:
 - ECU part number(s) [Refer to the **Parts Information** section for the **NEW PART NUMBER**]
 - Calibration ID(s) [Refer to the **Calibration Information** section for the **NEW CALIBRATION ID**]
 - Dealer Code
 - Repair Date
 - Change Authority [**This SB number**]
 - Affix the Authorized Modifications Label to the vehicle at the location shown in Figure 1. The Authorized Modifications Label is available through the MDC, P/N 00451-00001-LBL.
- Test drive the vehicle to confirm proper vehicle operation.
