## Rav4 EV drive unit "Milling" noise repair.

I recently purchased a used Rav4 EV with 126,000 miles, which had very loud whine, and scraping sounds at low speeds.

This uses an early Tesla drive unit, virtually identical to the 2013 vintage Model S drive unit, the main difference being the Rav4 has a parking pawl added, where the Model S does not need one.

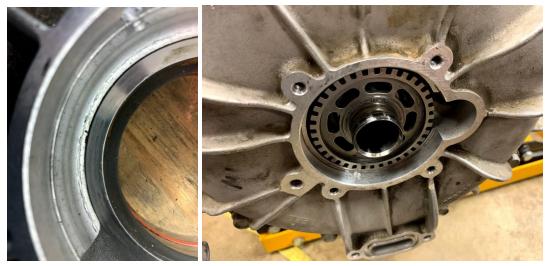
After removing the end cover, I found that the encoder wheel was scraping against the end cover. I believe this is due to axial play in the motor bearings. Here you can see marks left by the encoder wheel:

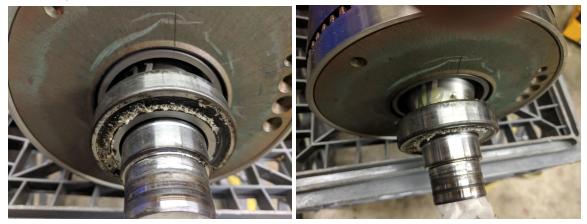
Motor rotor seal side bearing and seal surface. Notice the green discoloration on the rotor caused by the coolant leak.

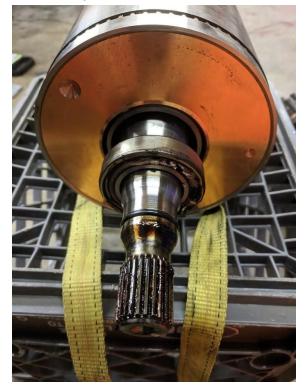
This is the gearbox side of the rotor. Notice how bright that copper is!

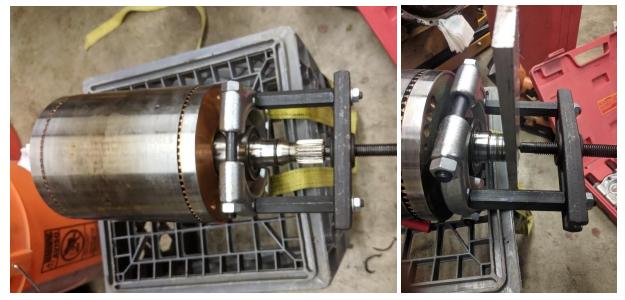
The rotor bearings are a hybrid ceramic bearing. After thinking about the engineering, I decided that this was the correct choice. One of the downsides, is that the only path left for any rotor voltages is through the gearbox bearing, which may be why it failed. I couldn't cross reference the part on the factory bearings to anything, so I found the closest bearing I could to the ones shipped from the factory.

The bearings can easily be removed with a standard bearing puller. You will need a block between the puller screw and the hollow shaft.

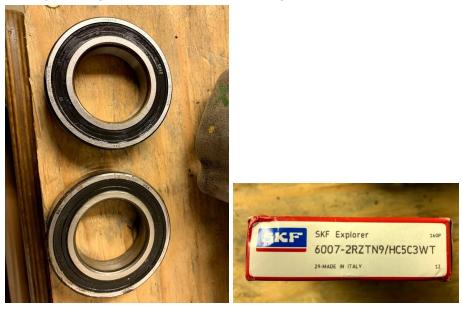
Factory bearing on the bottom, new bearing on the top:

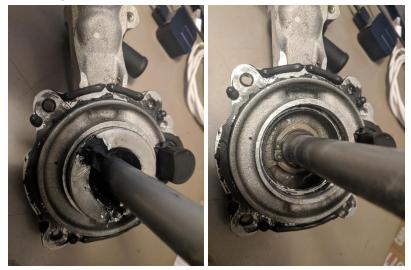
The rotor cooling system is quite ingenious. Water flows into a tube in the center of the rotor, then presumably goes through passages internally, then is returned on the outside of that tube. Only one mechanical seal is required to seal the rotating motor shaft. Unfortunately for me, this seal had failed, and I could not find a direct replacement. The seal dimensions are 30x55x8mm. It is a double-lip teflon seal with an excluder. If you happen to know where I could get these, please let me know!

I had to get medieval to remove the old seal:

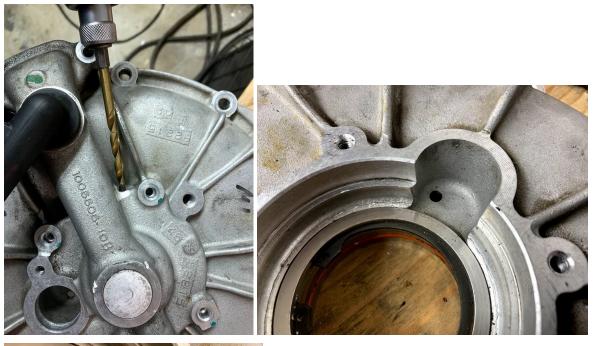
Here's the fun part, due to the way the motor is built, a leak at this seal will allow coolant into the motor, where I think it could pass through the power conductor passage into the inverter housing. I decided I'd rather dump the coolant overboard if it were to leak again. (which I anticipate it will, since I don't think my replacement seal is as good as the original)

I drilled a hole into the housing to function as a drain, then plugged the vent into the motor with JB Weld.

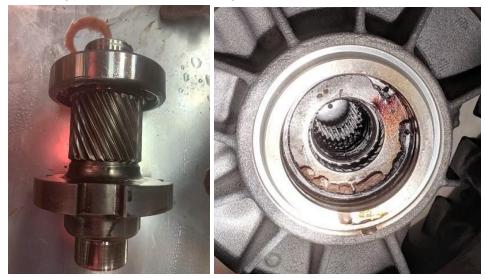
The pinion bearing shown here was in very bad condition. Based on the fretting pattern on inner surface of the outer race, I believe the failure was caused by electrical current flowing through the bearing while it was rotating. Tesla did attempt to mitigate this by adding a carbon brush ring between the motor and gearbox.

All bearings in the gearbox are C3 clearance. I would not recommend anything tighter due to the high RPM.

I chose to replace both pinion bearings. I couldn't get SKF bearings as fast as I wanted, so I settled on Schaeffler bearings from Amazon. The 6208 replacement was shielded, so I popped those off before installing.

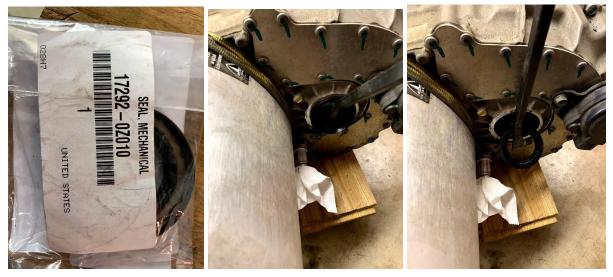
- The right side axle seal was leaking.
- The motor rotor coolant seal was leaking coolant into the motor housing.
- The motor rotor bearings had excessive axial play, which allowed the encoder wheel to rub against the motor housing.
- The gearbox pinion gear motor-side bearing had fretting damage, which caused the majority of the noise.

Replacing the axle seals was very easy. Just pop the old ones out with a pry bar, and hammer the new ones in with a large socket. Just make sure not to drive the new seals in too far, there are no stops inside the gearbox. The replacement seals are purchasable directly from Toyota. There are a few other external parts of the drive unit available from Toyota as well. The seal part number is 17292-0Z010.
