W210 Rear Sunshade Remove and Overhaul

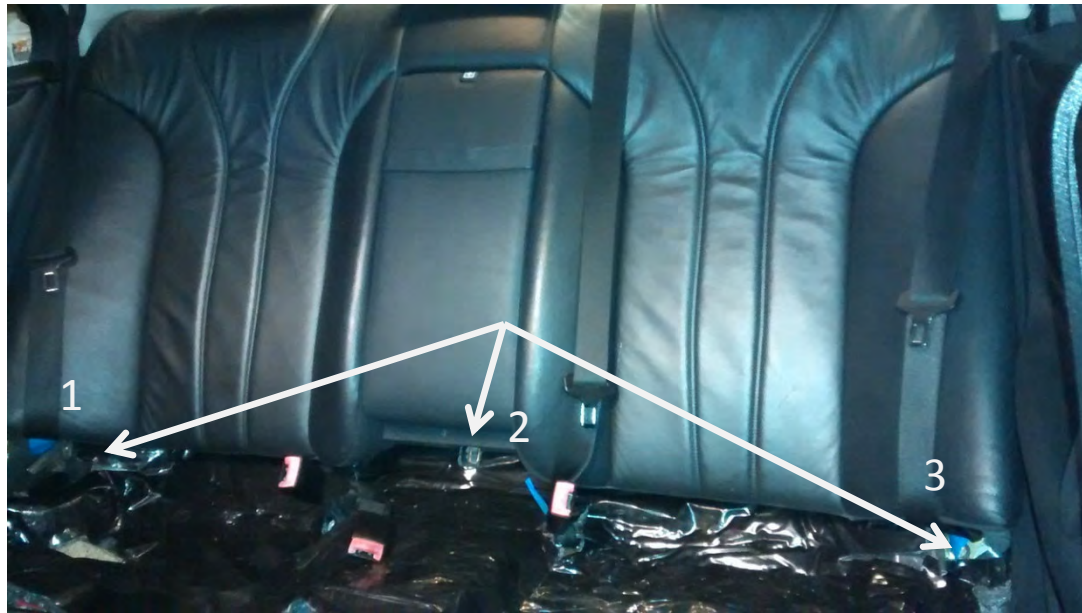
- Release two latches under rear seat cushion, lift out, set aside.
- Remove 3 each 10mm hex-head bolts from rear seat back, lift up cushion to release hooks on top, remove.

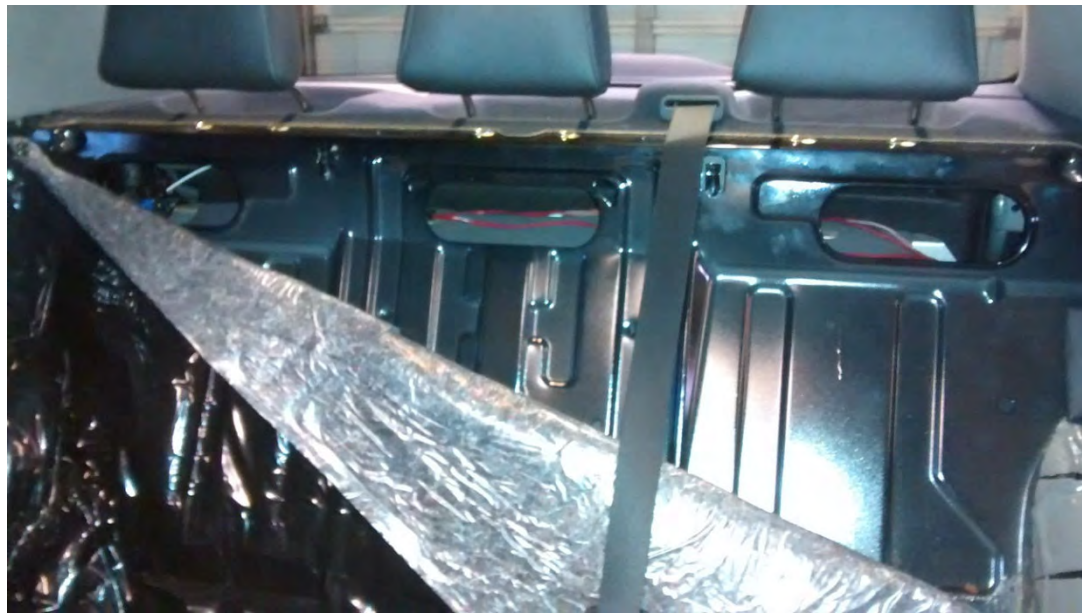
- Unhook and lower insulation out of the way.

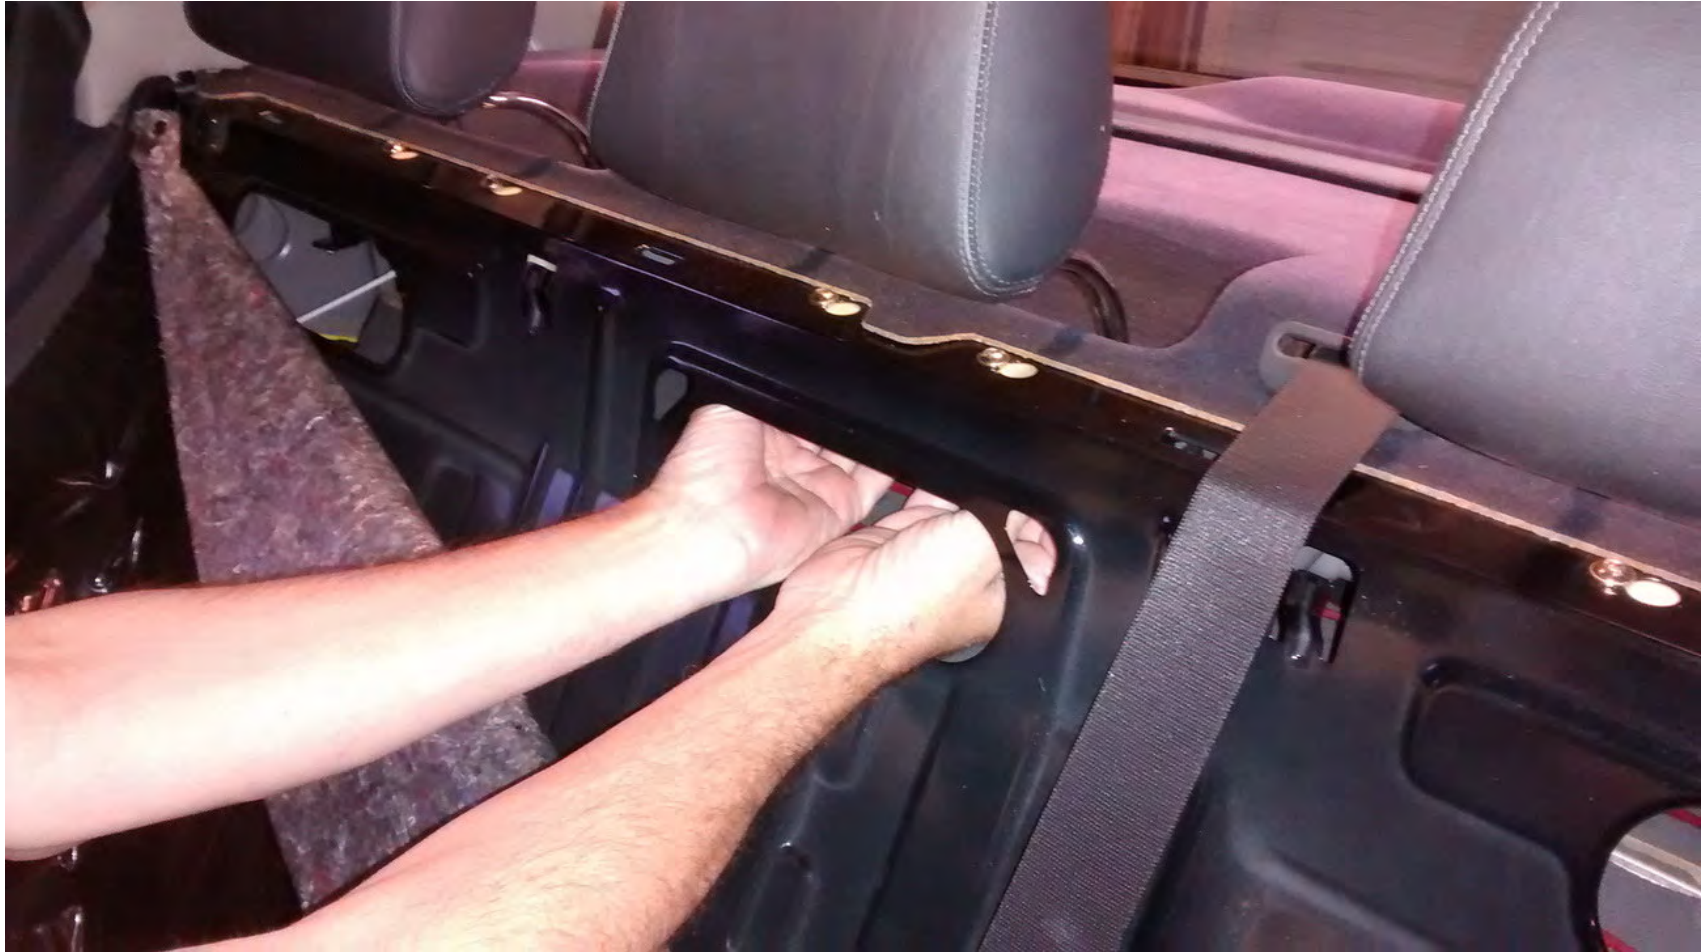
- Release plastic trim around headrest arms on package shelf (lift up front of plastic trim and then slide forward).
- Slide fingers along outside of plastic mounts into which the metal arms mount and feel for the plastic release levers. Lift the levers up and have another person slide the headrest to the rear or use your forehead to bump it out of the mounts. Repeat for each headrest. (NOTE: See next slide for lever photos.)

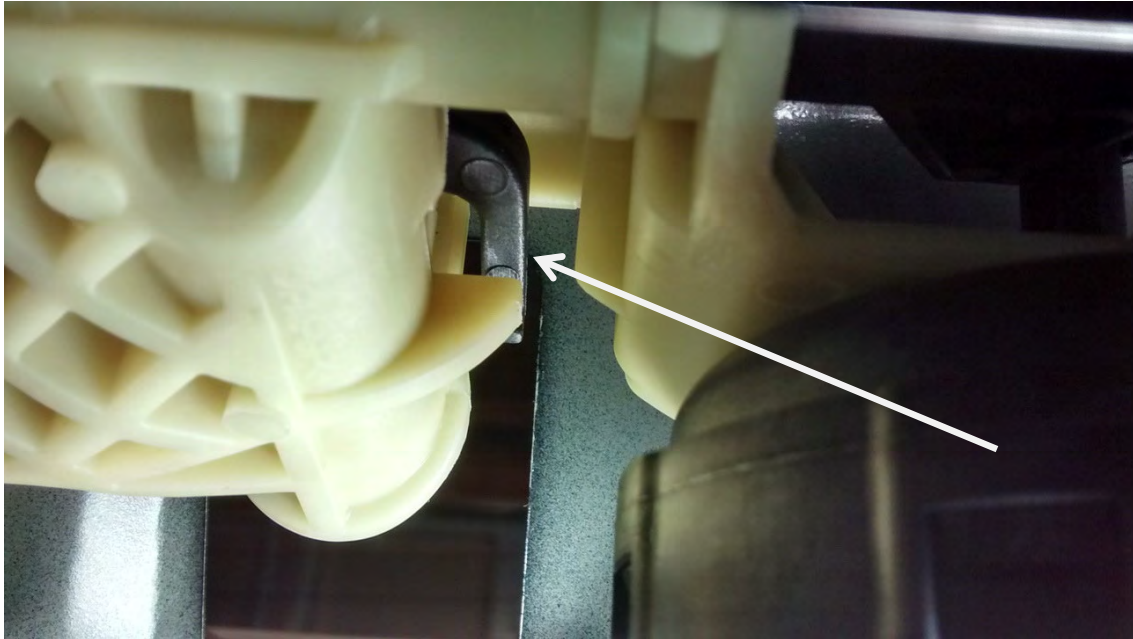
-Looking from front to rear.
Remember, one on each
side.

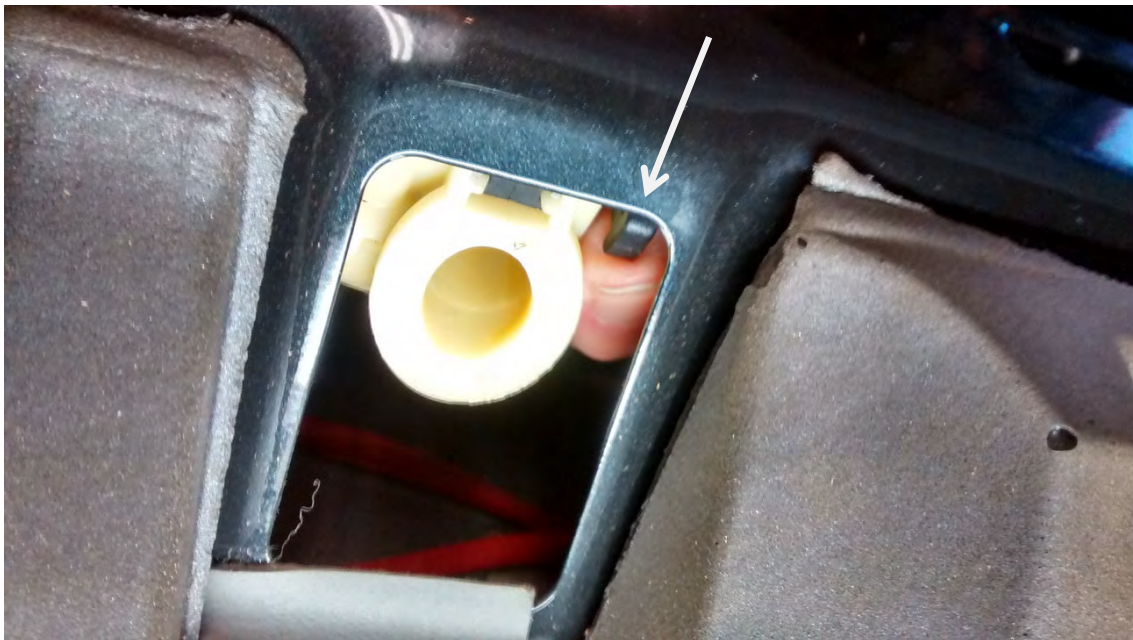
-Looking from rear to front
after headrest removal to
show lever raised by finger.
Remember, one on each
side.

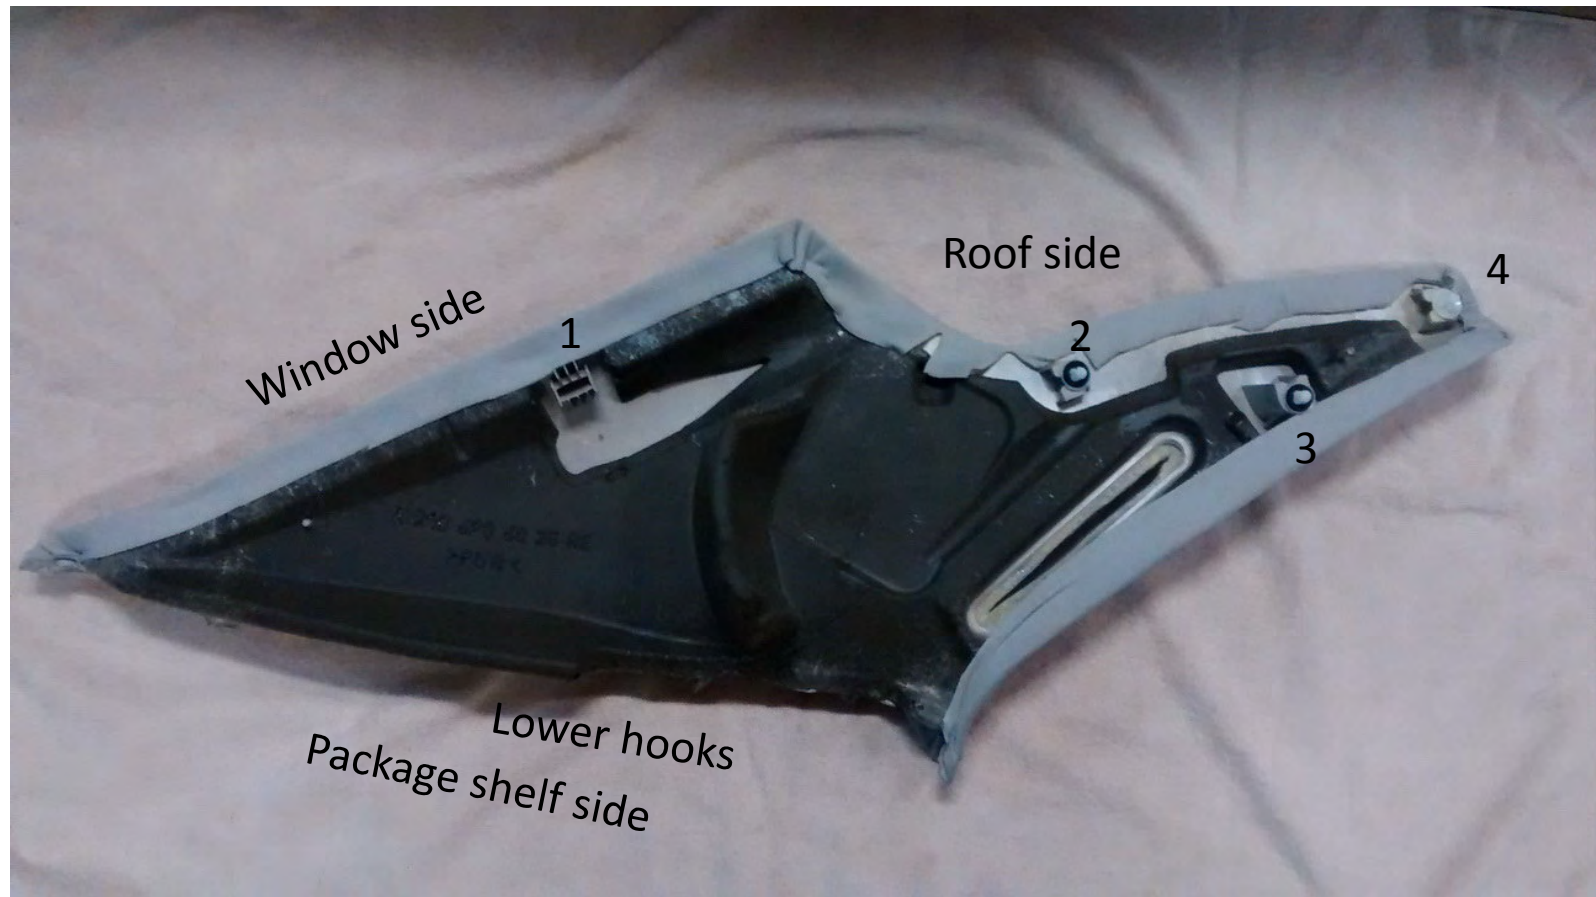
-Remove C-pillars. Pull near the top towards center of car until plastic fastener clips come loose, then slide trim forward to release lower hooks, lift and slide along seat belt out of the way.

-#1 is a metal clip that will most likely remain attached to the car. 2, 3, and 4 are plastic tabs that will most likely break. 011-988-76-78-M58 is the part number for the plastic clips.

NOTE: You do not need to remove the C-pillar from the seat belt and the car; this one was removed to be recovered.

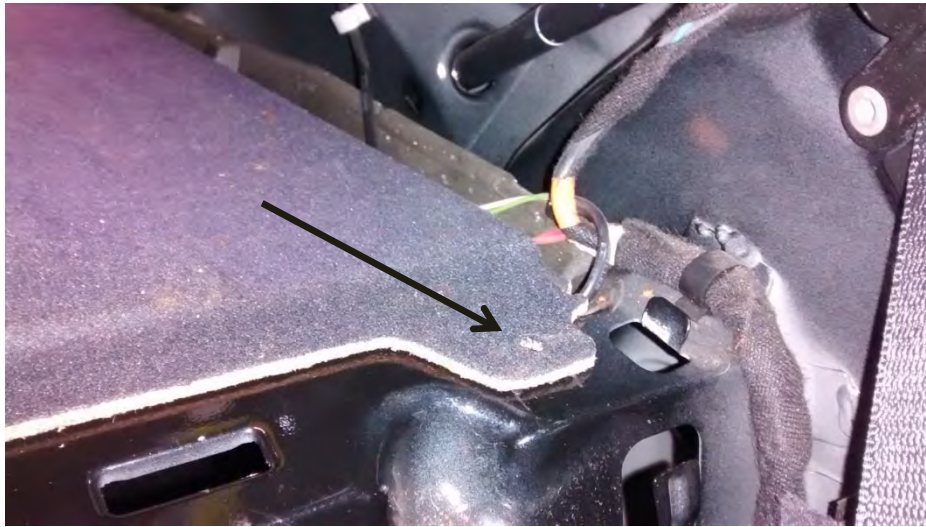
- Remove plastic pins at two front corners. Disconnect center seatbelt.
- Package shelf is held in place by multiple plastic fastener clips. Expect the clips to break, the brackets to pull loose from the backing, and the package shelf to pull apart into two separate pieces along the horizontal joint line in photo.
- Have a plan to repair the plastic around the brake light. It will most likely break.

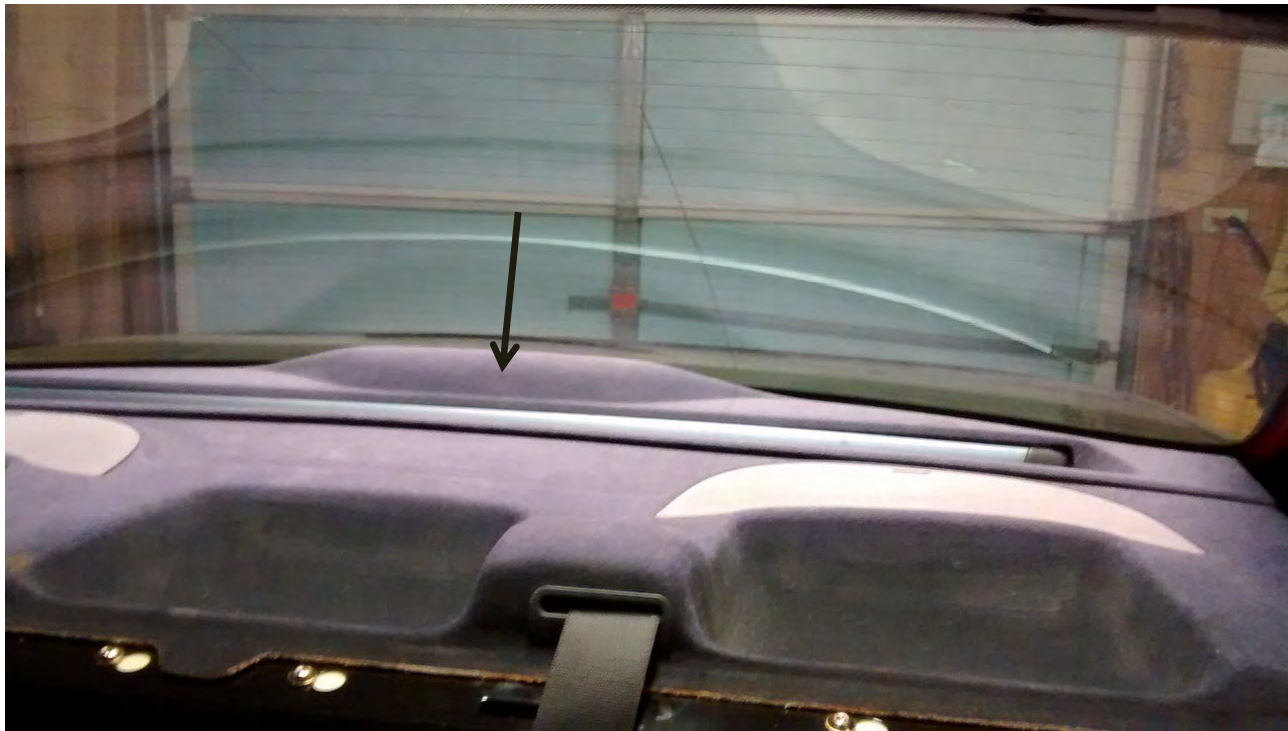
- Arrow points to location of 3rd brake light wire under the package shelf. Just pull the connector (small!) straight down. (if you can reach it.)
- Plan now on the need to rebuild the package shelf. See later slide.

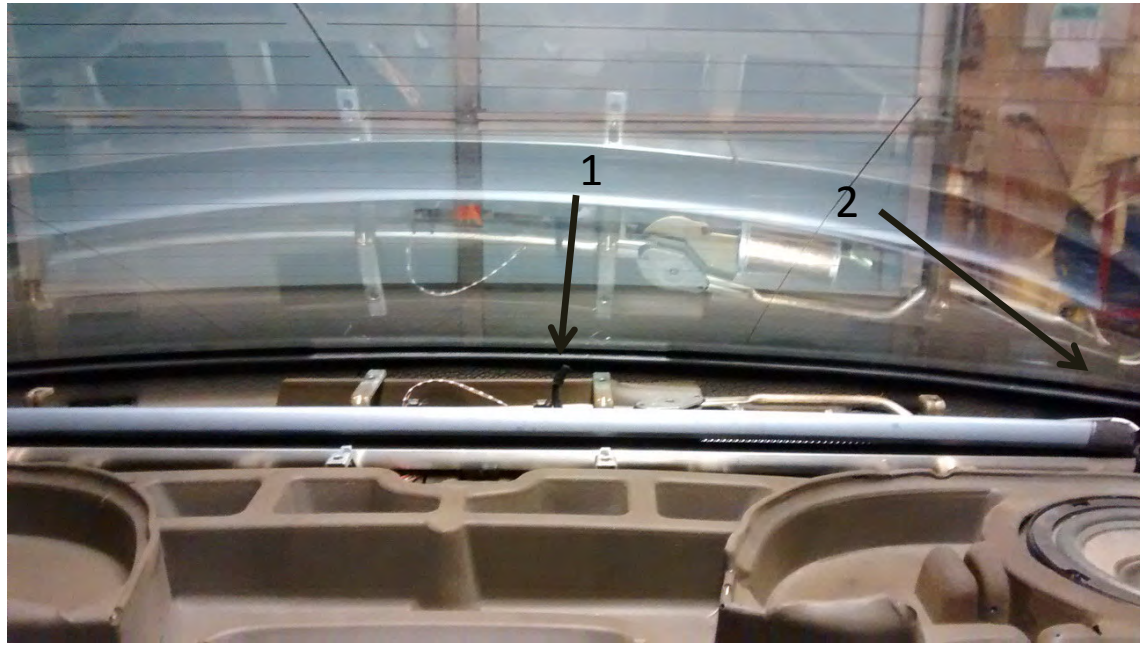
-Package shelf removed.
Ready to remove sunshade
assembly. Arrow 1 points to
3rd brake light connector.
Arrow 2 points to sunshade
motor connector.

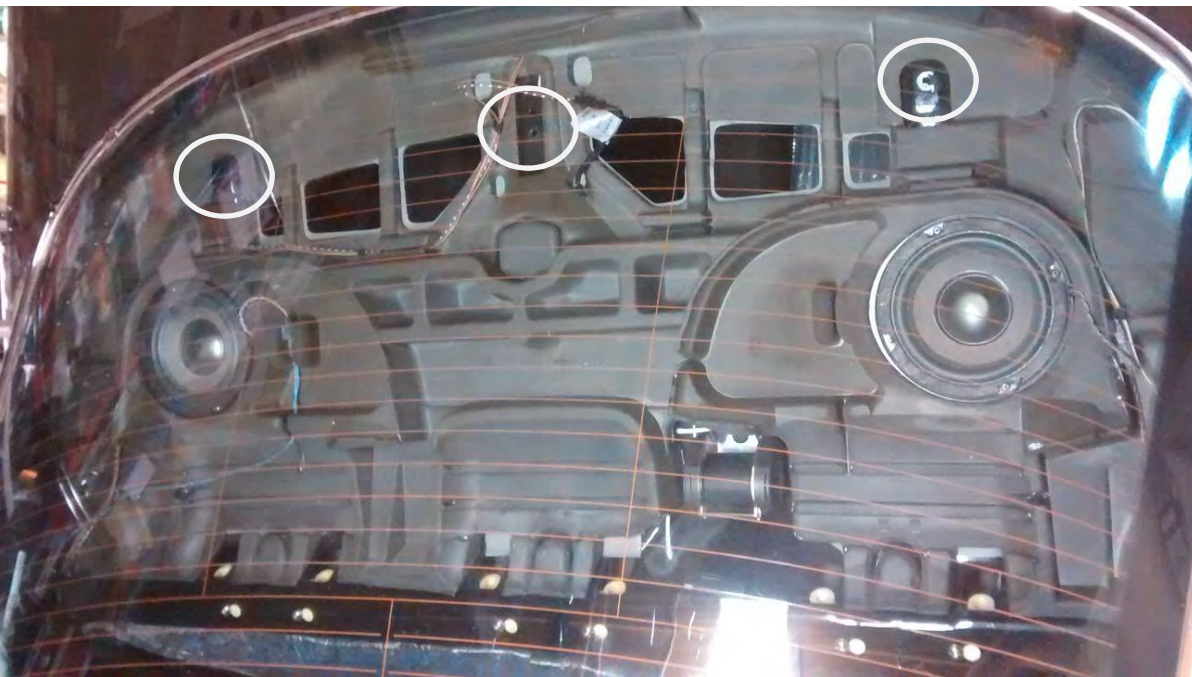
-Sunshade removed. 3 each
10mm hex-head nuts must
be removed from under
shelf in the trunk. Locations
circled.

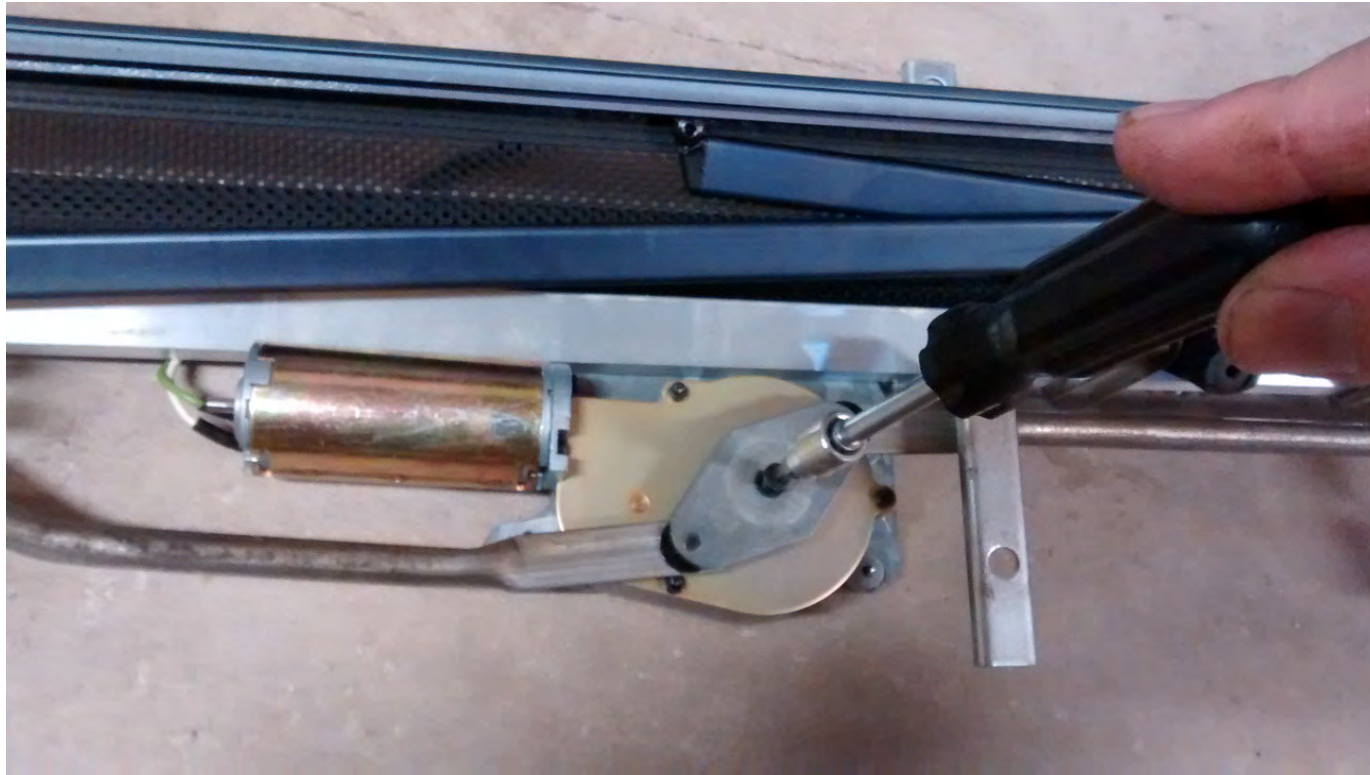
Remove one each shaft Torx bolt to release swing arms. Remove three each Torx bolts to release motor mechanism. NOTE: New mechanism may require an adaptor (included with new part) to fit the original swing arms.

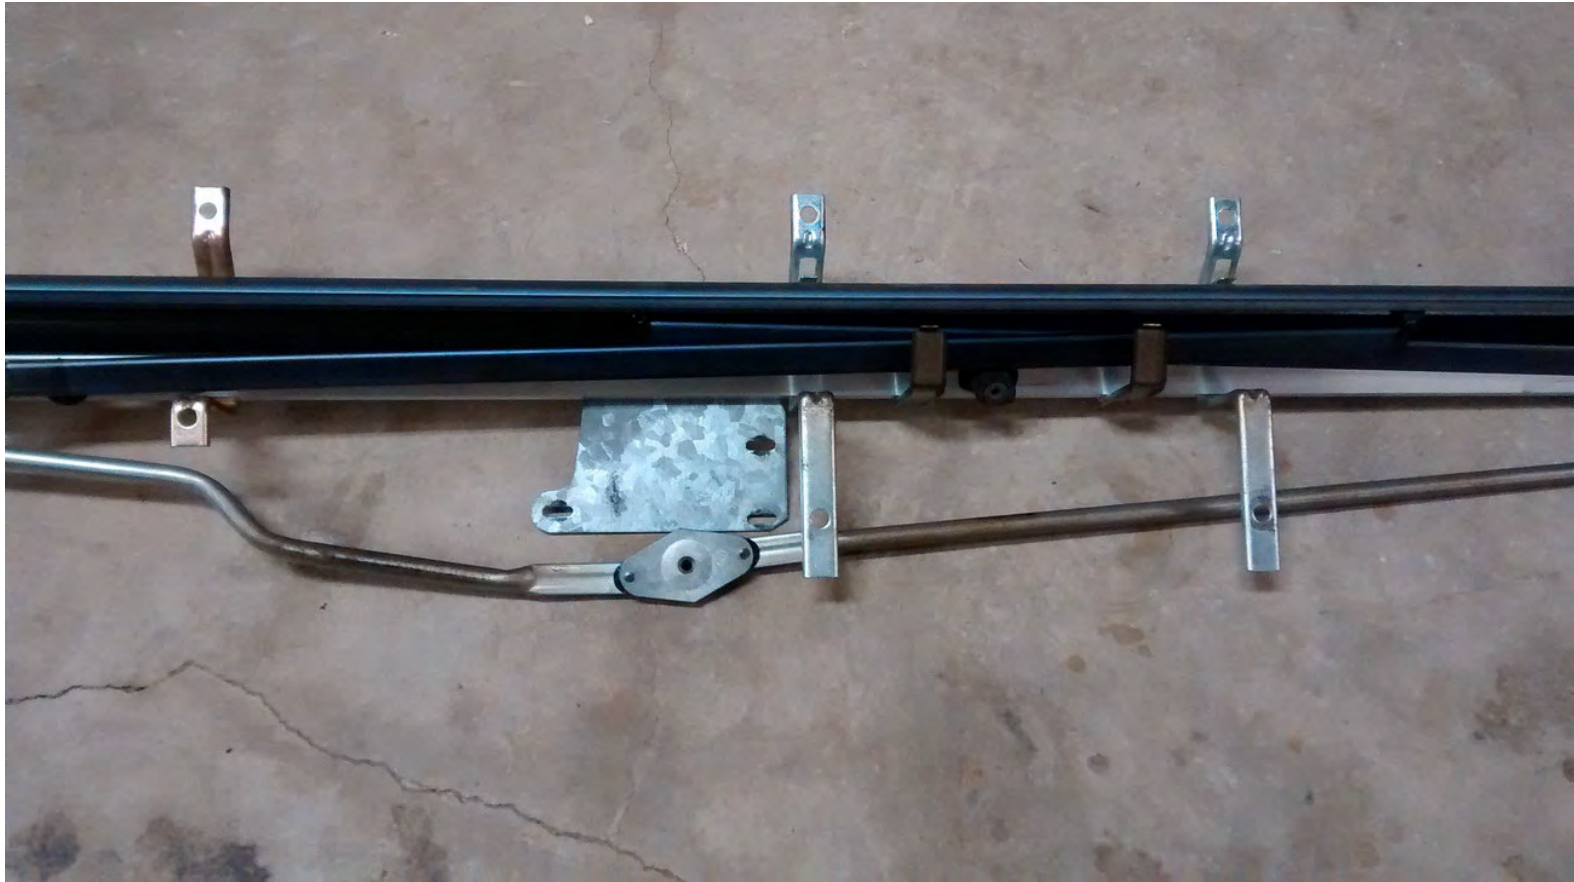
Now is the time to apply a high-quality long-lasting lubricant to all pivot points, bearings, and sliding surfaces.

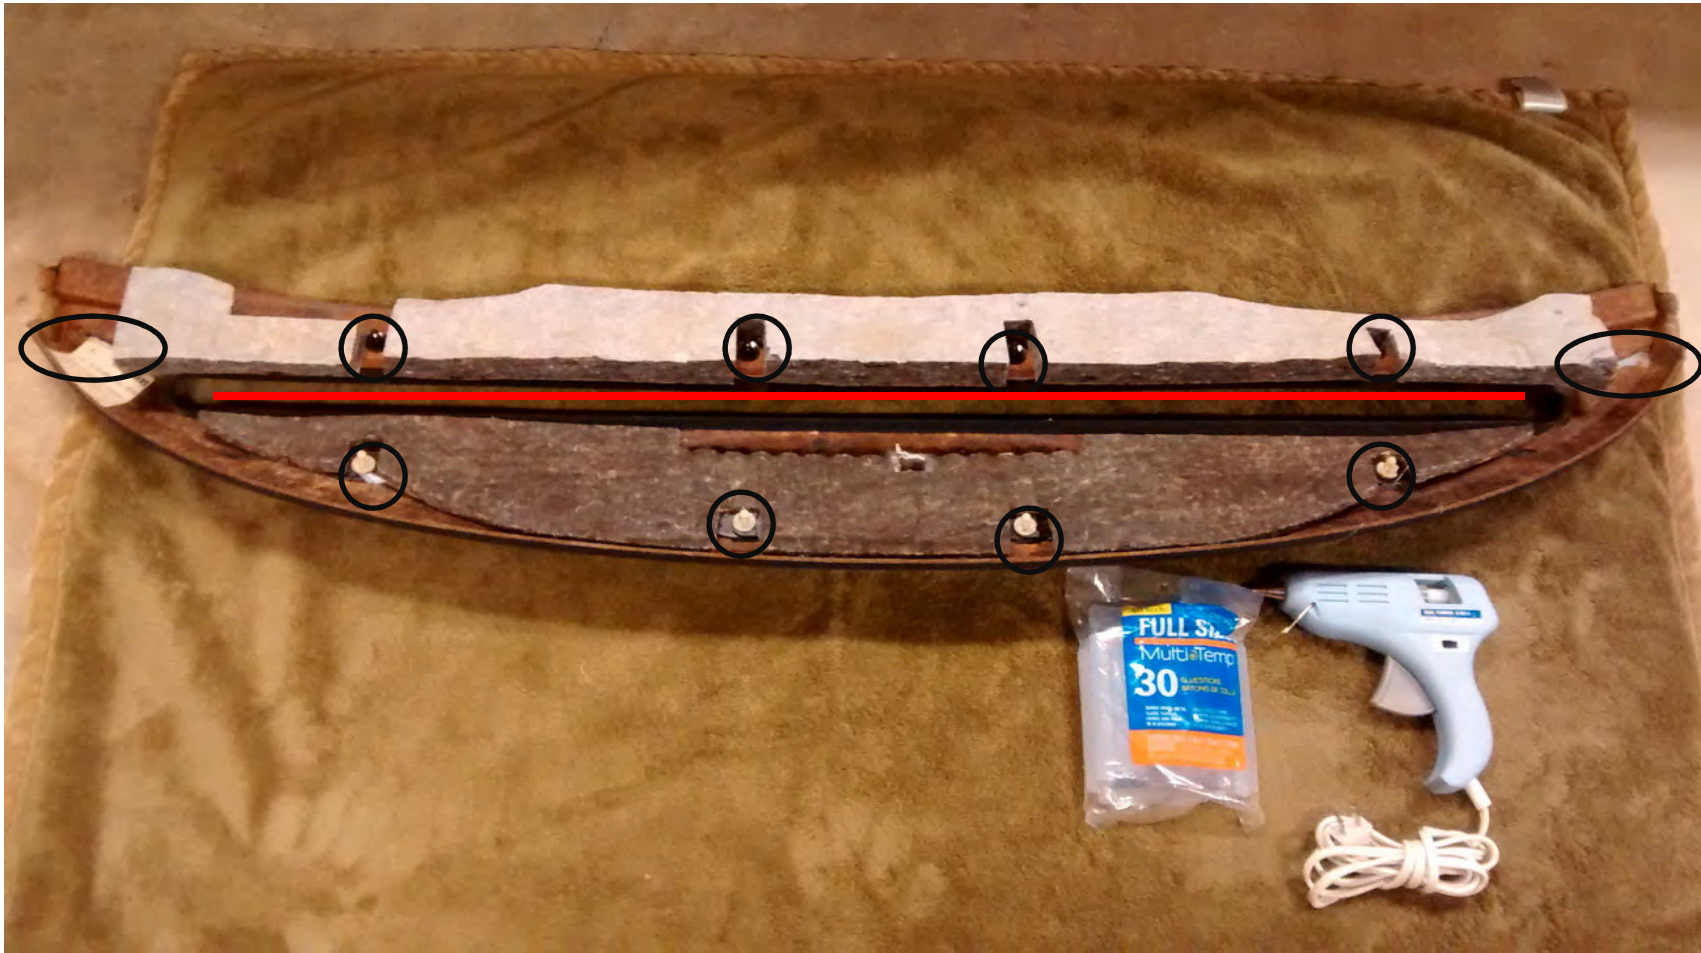
-Circles indicate plastic clips that will break and the brackets underneath will separate from the backing. Ovals and red line indicate where the package shelf will separate into two pieces. Old age takes its toll. Use a hot-glue gun or industrial adhesive (hardware store in adhesives section) to rebuild shelf. I recommend the industrial adhesive although it will require 12 to 24 hours to set.

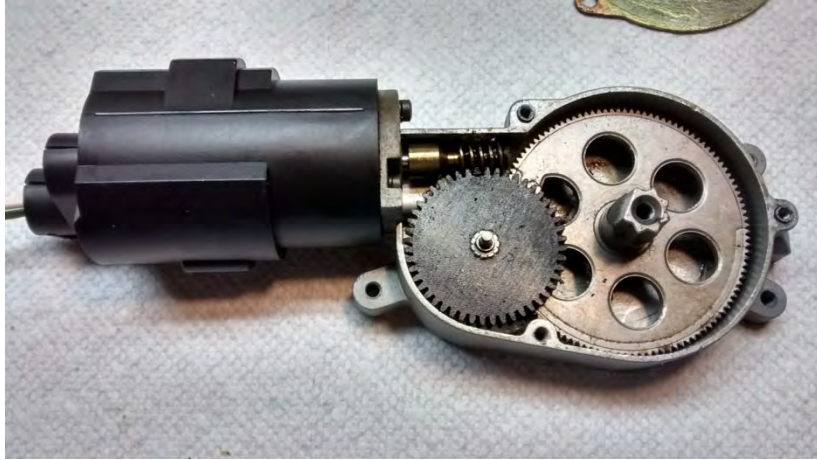
-Root cause: Large gear is strongly spring-loaded to rotate clockwise placing large load on shaft bearing of intermediate gear.

Arrow below shows bearing in housing that actually elongated enough that the intermediate gear tilted and caused the gear teeth between it and the large gear to jam.

-This photo is after I attempted to use hammer and punch to “mold” bearing back into shape. No success.
