Below is the method I used after the excellent pictures from kuhlmeister

I had bought aftermarket heater pads in order to replace mine as neither the bottom or back of the seat heated up. I checked I had voltage at the plug under the seat but I had no continuity between the wires in the seat. After reading of kuhlmeister's repair I decide to try repair before replacement

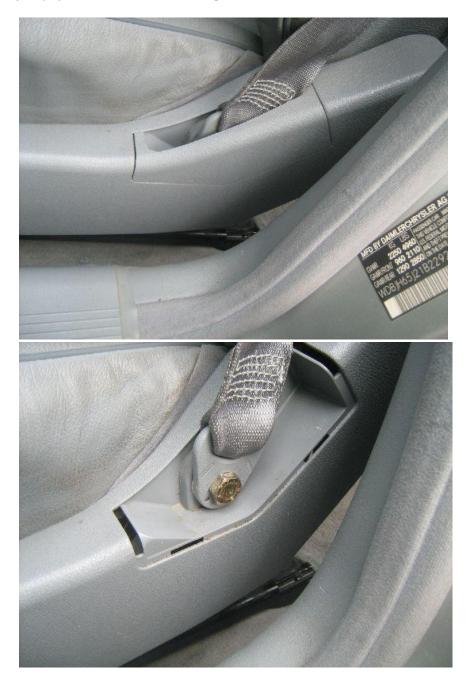
First put the seat into the middle of the rails and raise it to the highest point front and back and lower the headrest to the bottom stops. Then undo the door side seat belt bolt. Its under a plastic cover that just pops off from the bottom edges.

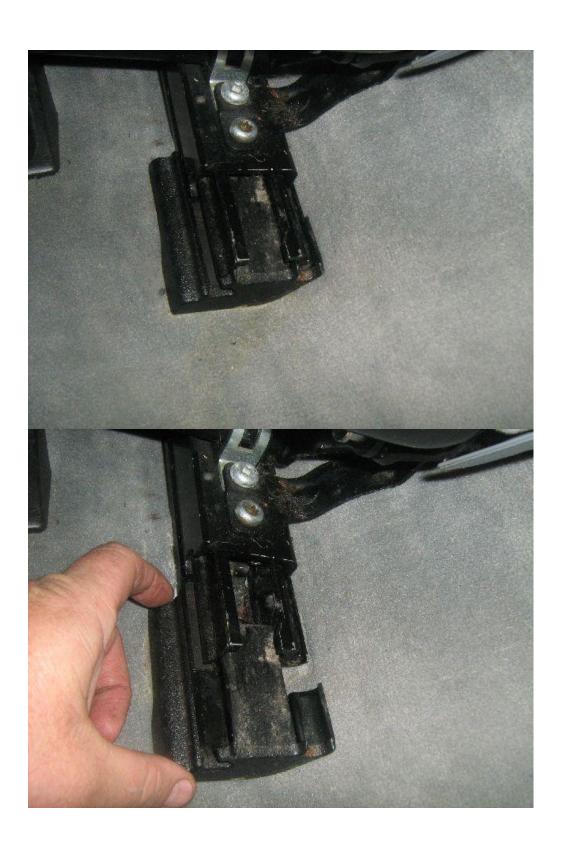
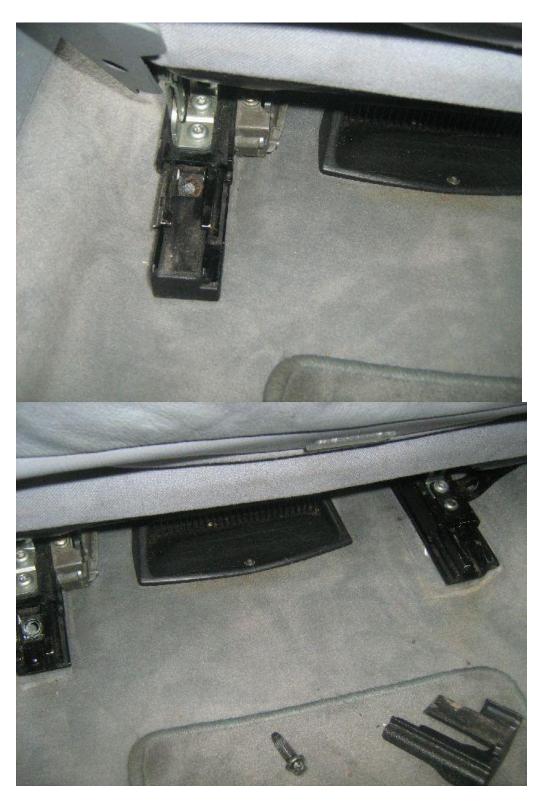
The seat in the right position pull out the rear covers on the seat rails – just finger pressure – to expose the bolts. The fronts are open. It takes a 12mm internal star

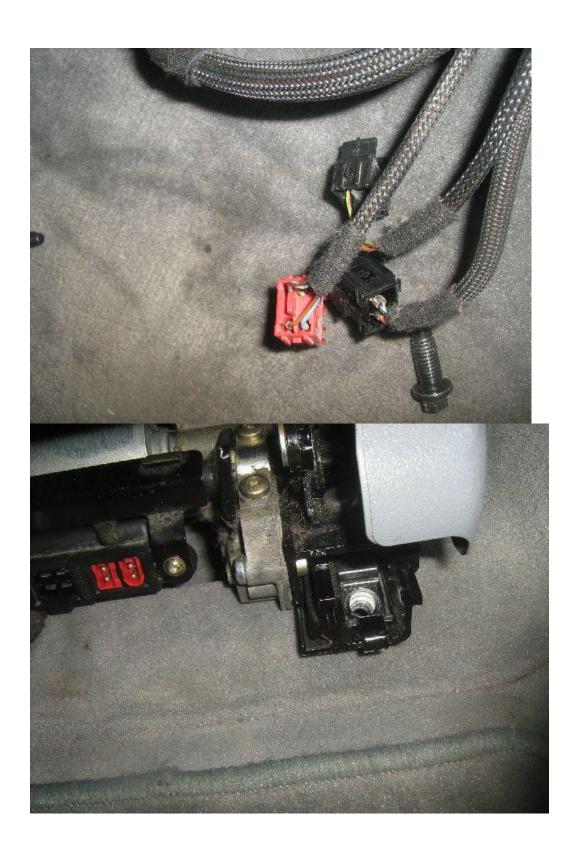
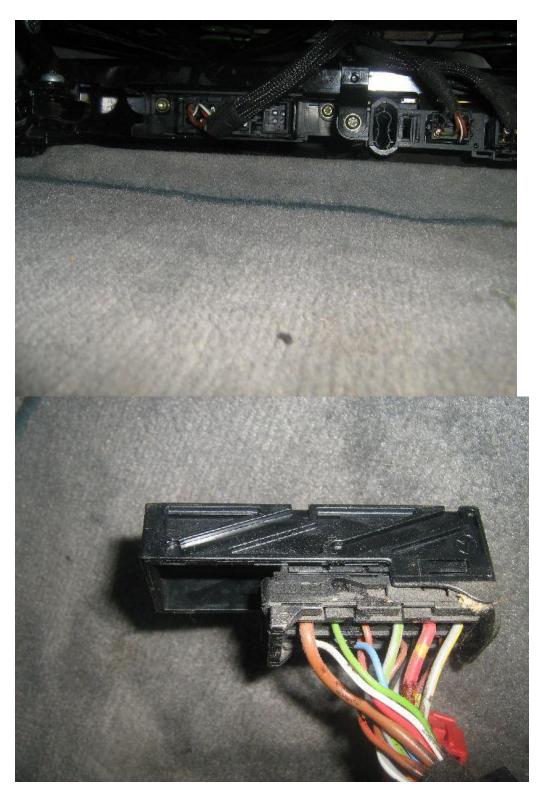
Remove the wiring from the front connectors – the plugs on the door side just pull out but the big connector to the seat module has a slider. As you pull it towards the door it unlatches the connector and pops it out for you.

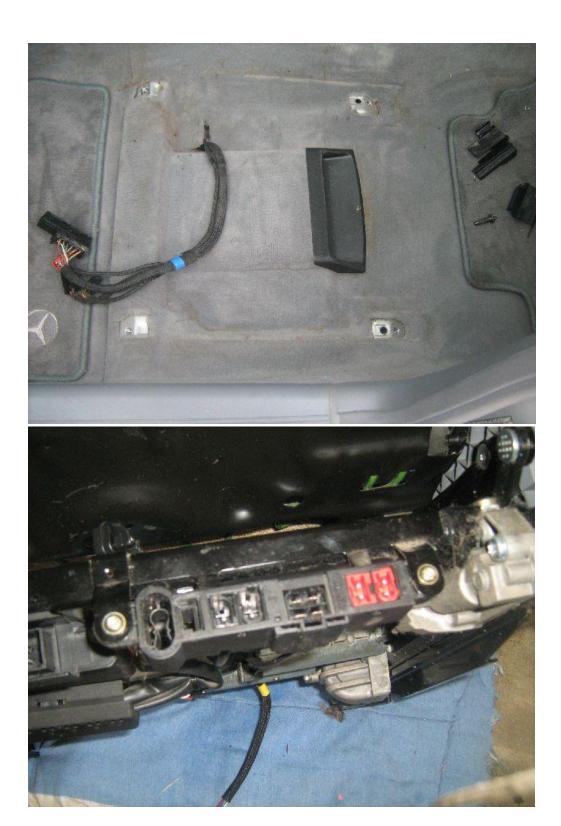
Then just lift out the seat. Make sure you have some blankets or similar on the floor to lay it on, you can also get at nthe wire connectors easier. Undo the 2 bolts and remove the small connector that has the seat heater wires in it.

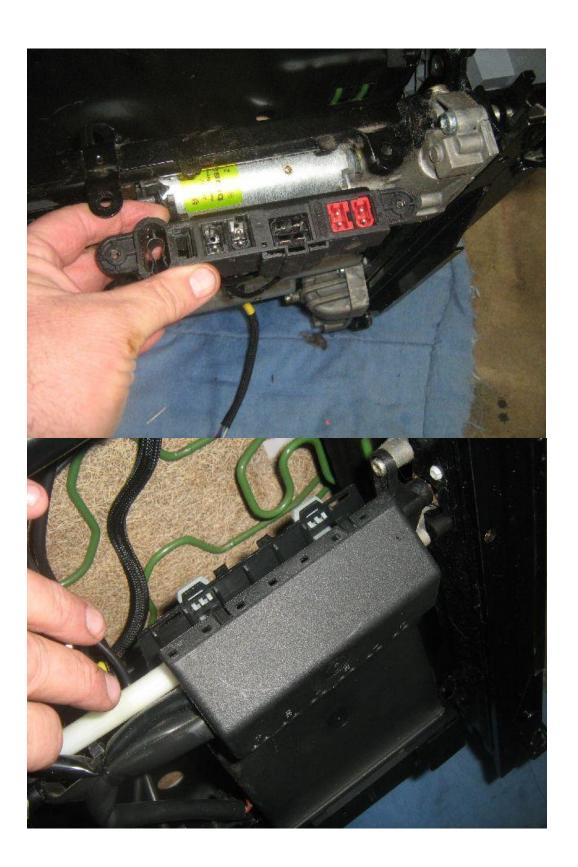
Then trace those wires back to the main module pop the back open and unplug the wires where they go into the control module

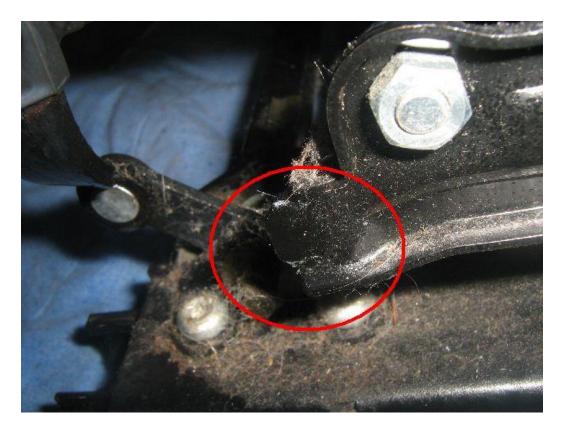
Once you have it out its easy to work on and you now have to separate the back from the bottom. First undo the one screw on the back of the plastic cover that goes from the door side front to back, the rest of the panel pops off once the screw is out and I have marked the connections in red circles. The prong slides into the cover so you actually push the cover towards the front of the car to remove it.

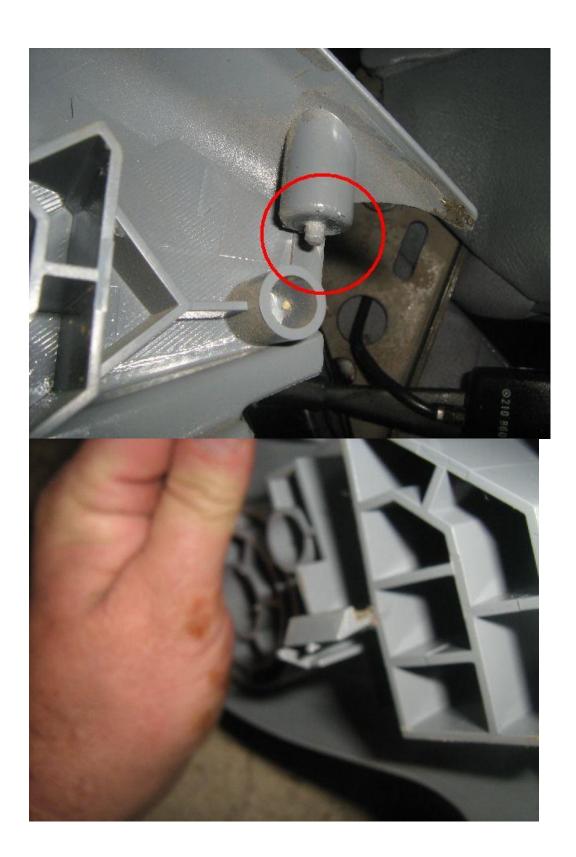
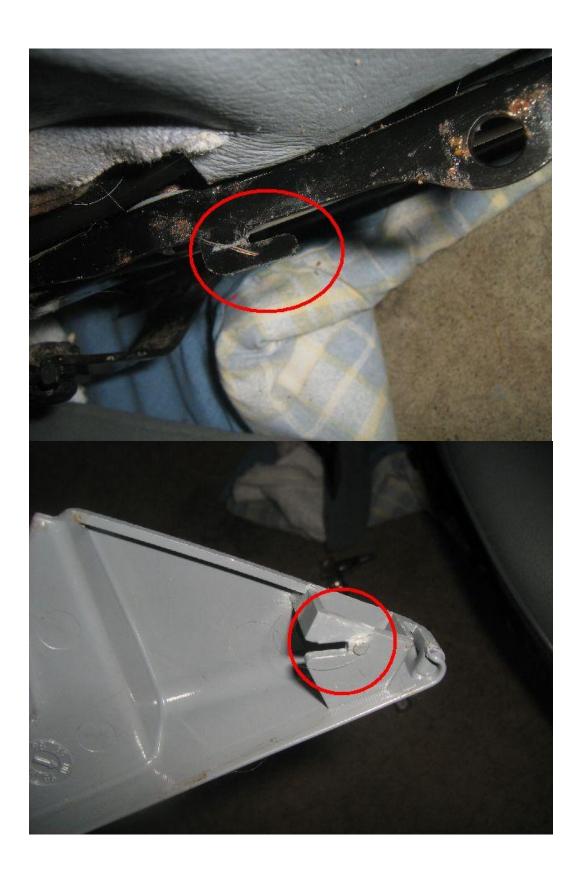
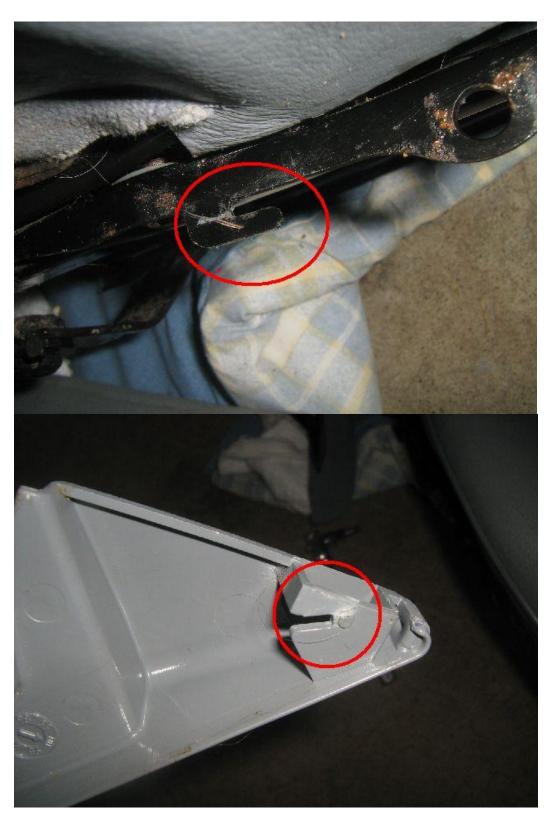
Then flip the seat over and remove the other side and the bolt into the seat belt latch. The plastic cover is held in by a small stud that locates into a hole. Just pull the back of the plastic towards the rear of the car and the stud pops out then you push it forward to detach the slot off the tang on the frame and wiggle it off the seat belt latch holder

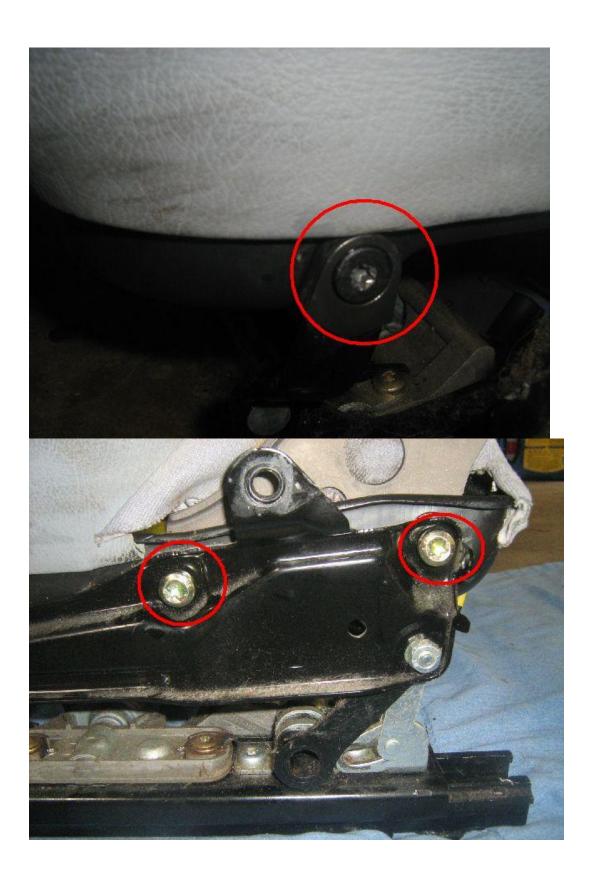
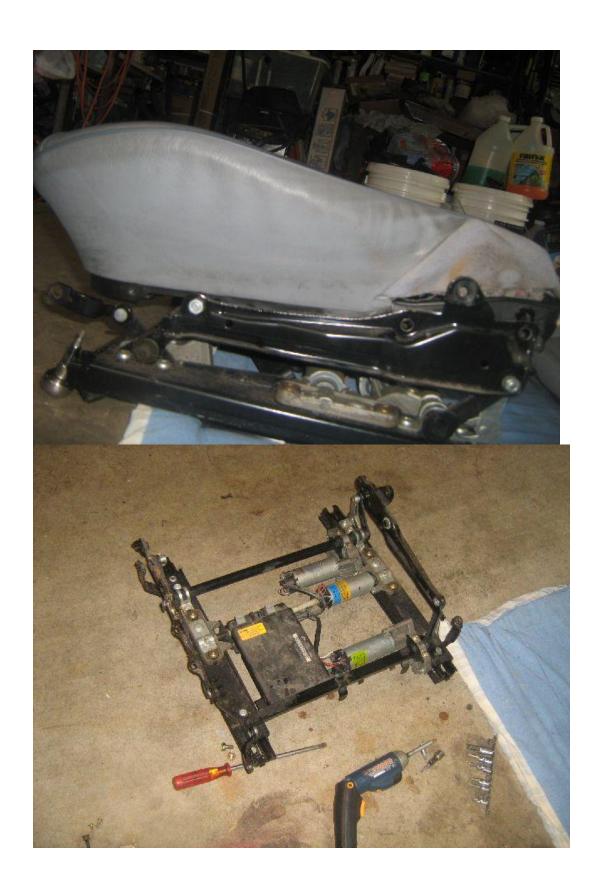
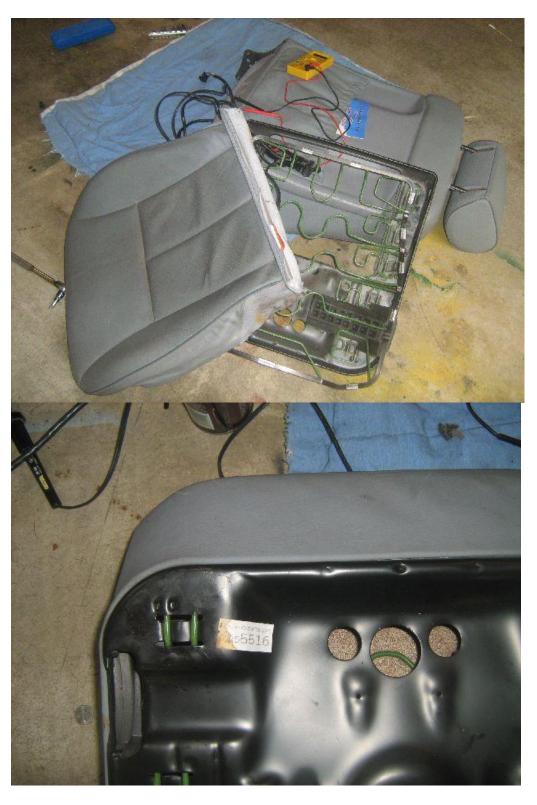
One they are off you can undo the very front bolt and the two rear bolts on each side . this will separate the base and motors from the seat base and the seat back from the seat bottom

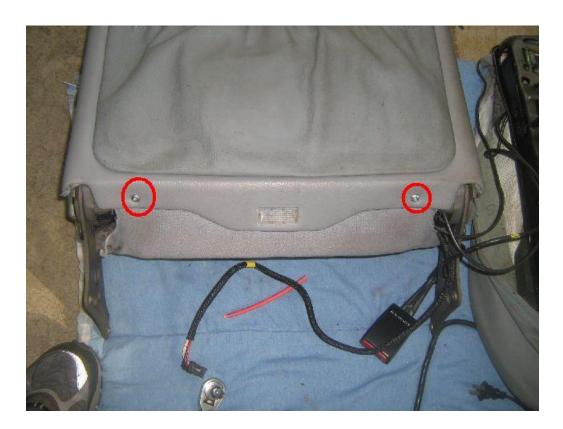
To get to the seat top heater you can remove all of the leather but the most likely place is the left bolster panel so I just removed the back panel and peeled the leather up from the bottom

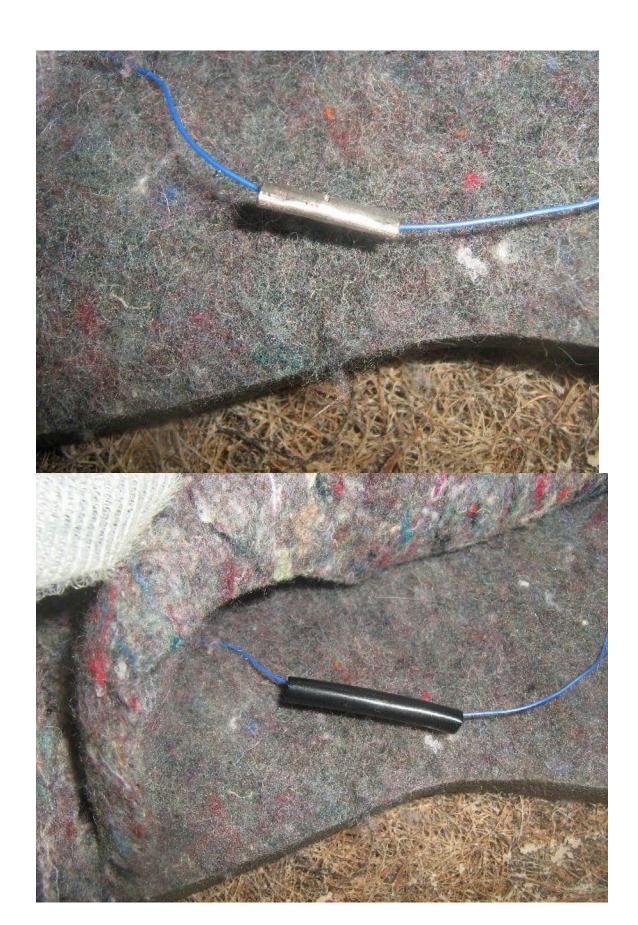
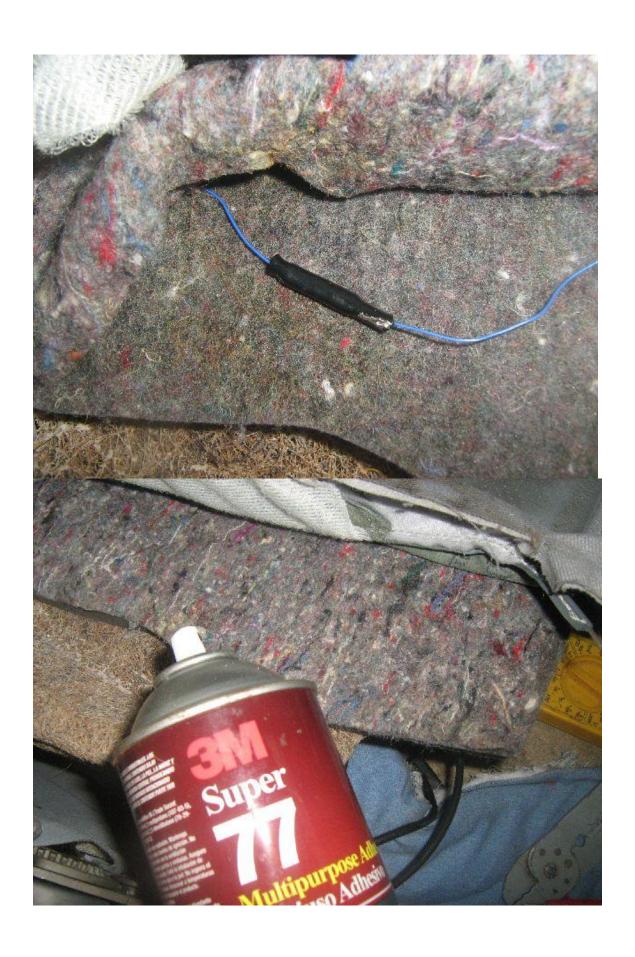
For the base you then apply pressure to the seat leather and peel it off the base – its really easy. The cross bracing in the leather is held onto the seat pad by white plastic clips, just push the steel bard down and against the clip retainer and then pull up and it will pop out of the clip. I did exactly the same as kuhlmeister and checked the left bottom bolster first as that is the one that gets the most beating as you get in and out and there was the scorch mark!. One just has to peel back the felt layer at the foam, it may tear a little but the wires sit between the felt and the foam. I repaired mine a little differently, I cut back to good wire and then slid on a crimp connector and a few inches of shrink wrap and then soldered the 2 wires together fitted the crimp over the solder and shrink wrapped it all together. I used 3m 77 spray adhesive on the felt backing and stuck it all back together.

You have to put the crimp and the shrink wrap onto the wire first obviously! Otherwise you are a bit stuck.

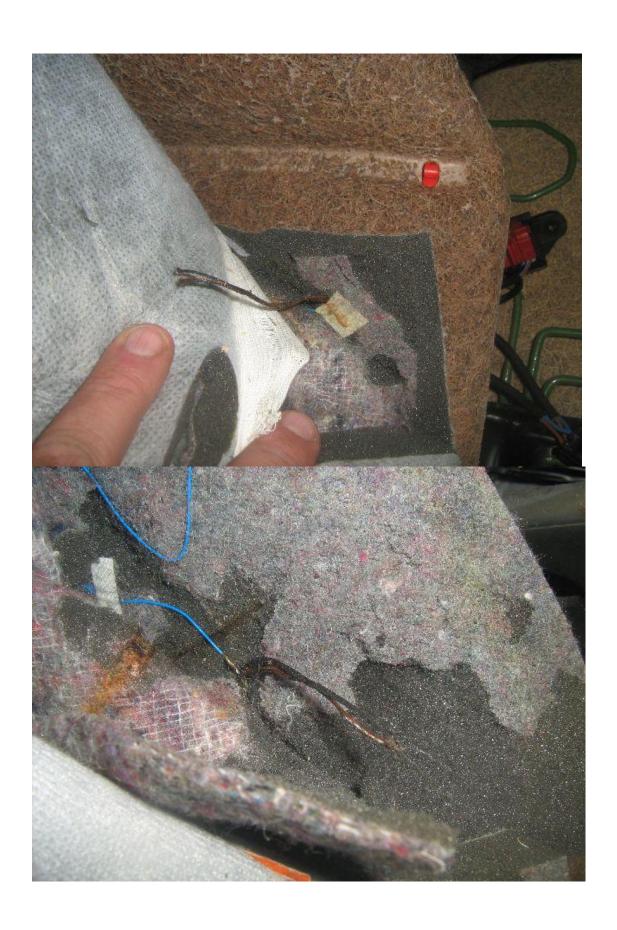
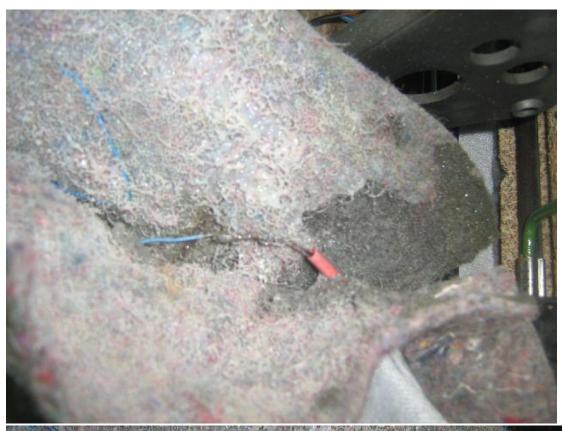
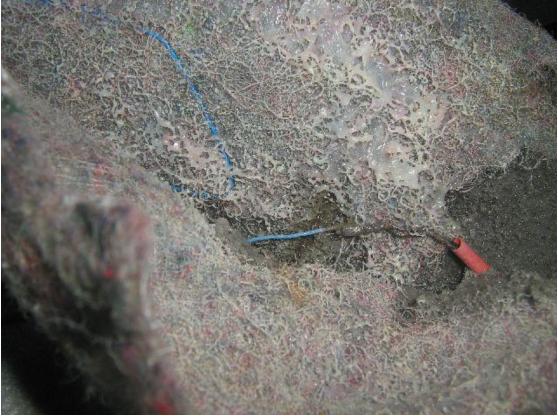
The damage on the seat back was similar – in the left bolster – but was actually caused by the original manufacturer sewing the braided line that caries power to the heating wire into the seam. Every time the seat moved it would bend the braided wire which eventually gave out. I used some solder wick to repair the wire (that seems to be what they used originally) but normal 14 or 16 gauge wire would work as well. I didn't even remove the leather for the back, just removed the board and then unclipped the bottom leather from the tangs. Unclipped a few of the retainers and I could easily access everything I needed to. The back uses red clips not white ones but they work the same way.

. Hey presto all done. Just check for continuity before you reassemble. Mine had about 3 to 4 ohms of resistance once fixed.
