INSTRUMENT CLUSTER LCD DISPLAY FIX FOR MERCEDES W210 MY 2000, ALSO APPLICABLE TO W202, W208 AND OTHER MODELS

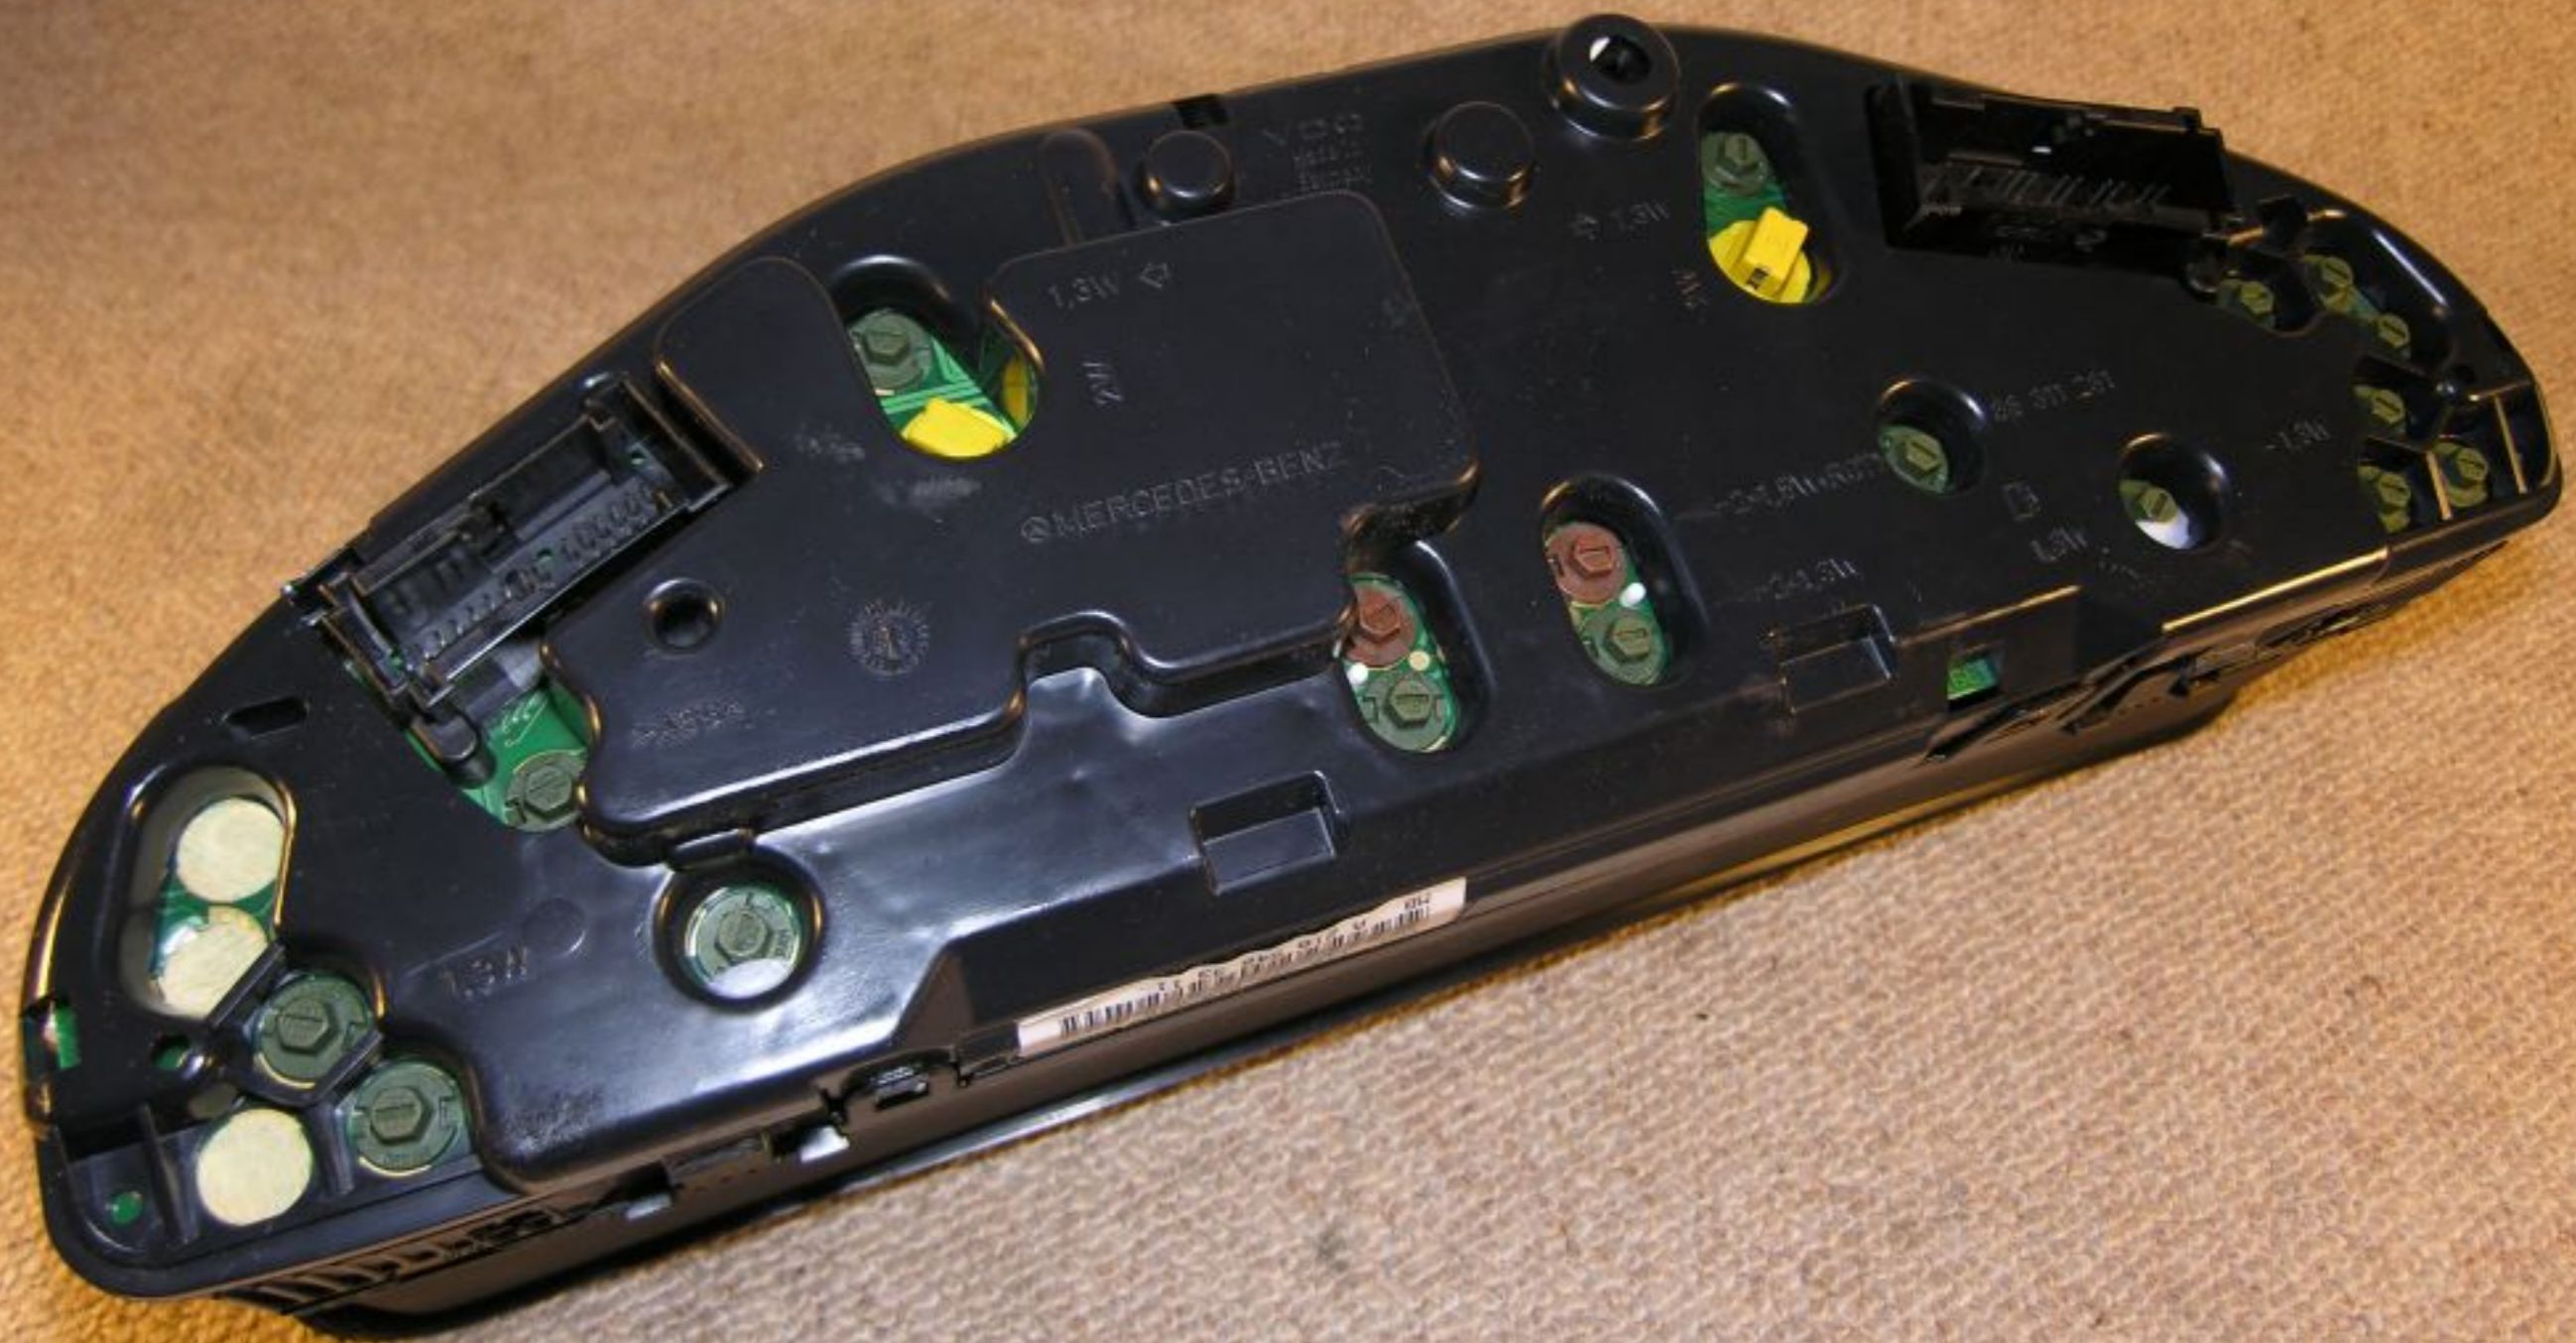
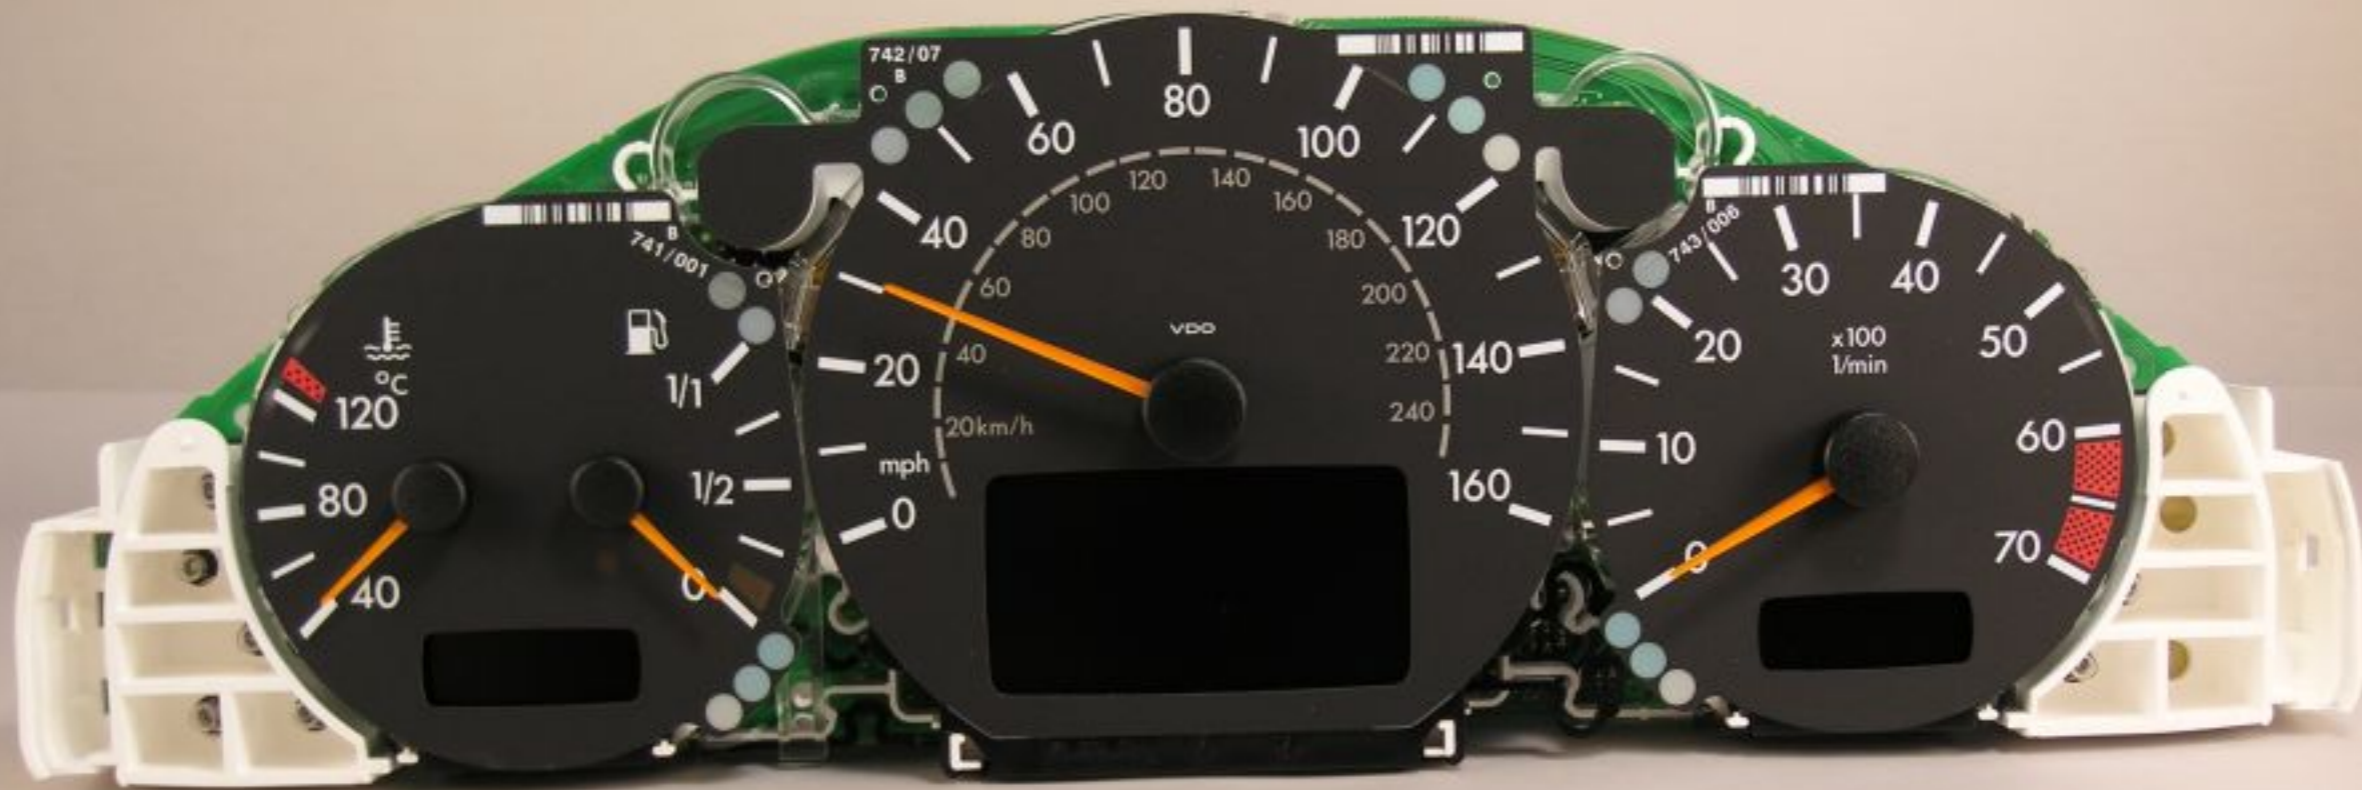
**THIS IS WHAT WE GET – PRETTY MUCH
SELF-EXPLANATORY**

ONCE WE HAVE THE INSTRUMENT CLUSTER ON OUR WORK TABLE, WE MUST TAKE IT OUT OF ITS SHELL BY UNSNAPPING BOTH HALVES (EASY TO FIGURE OUT) APART.

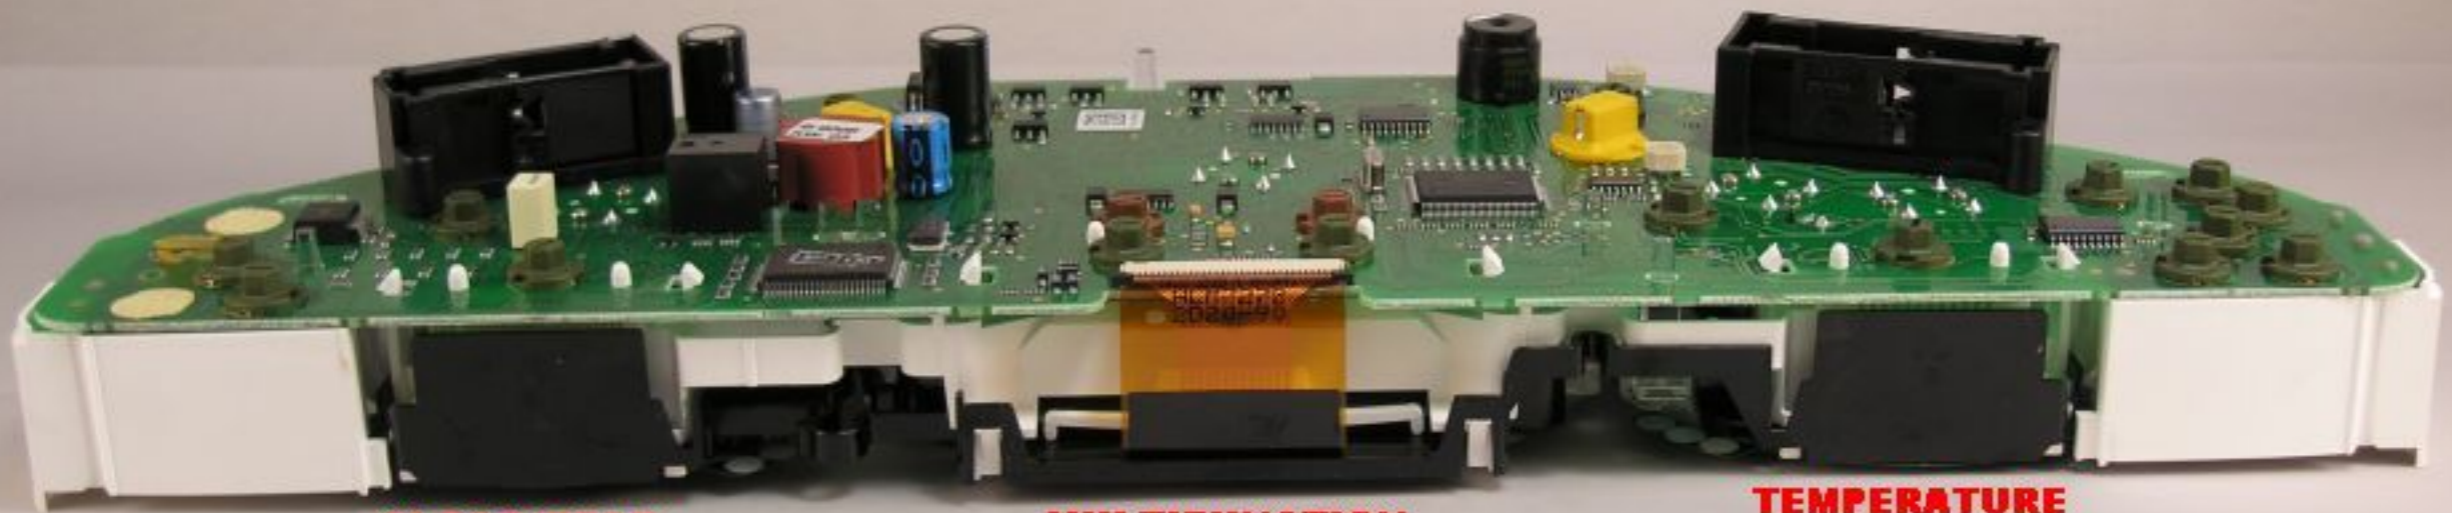
... AND THE BACK/BOTTOM VIEW

**CLOCK/GEAR
SELECTOR
DISPLAY**

**MULTIFUNCTION
DISPLAY**

**TEMPERATURE
DISPLAY**

**FREE ALL SIX SPRING PINS SO AS TO
SEPARATE CIRCUIT BOARD FROM MAIN ASSEMBLY.**

**NOTE WE ARE NOT ATTEMPTING TO REMOVE
OR DISASSEMBLE ANYTHING BUT
CREATE A GAP TO WORK ON THE RIBBON CABLE(S).**

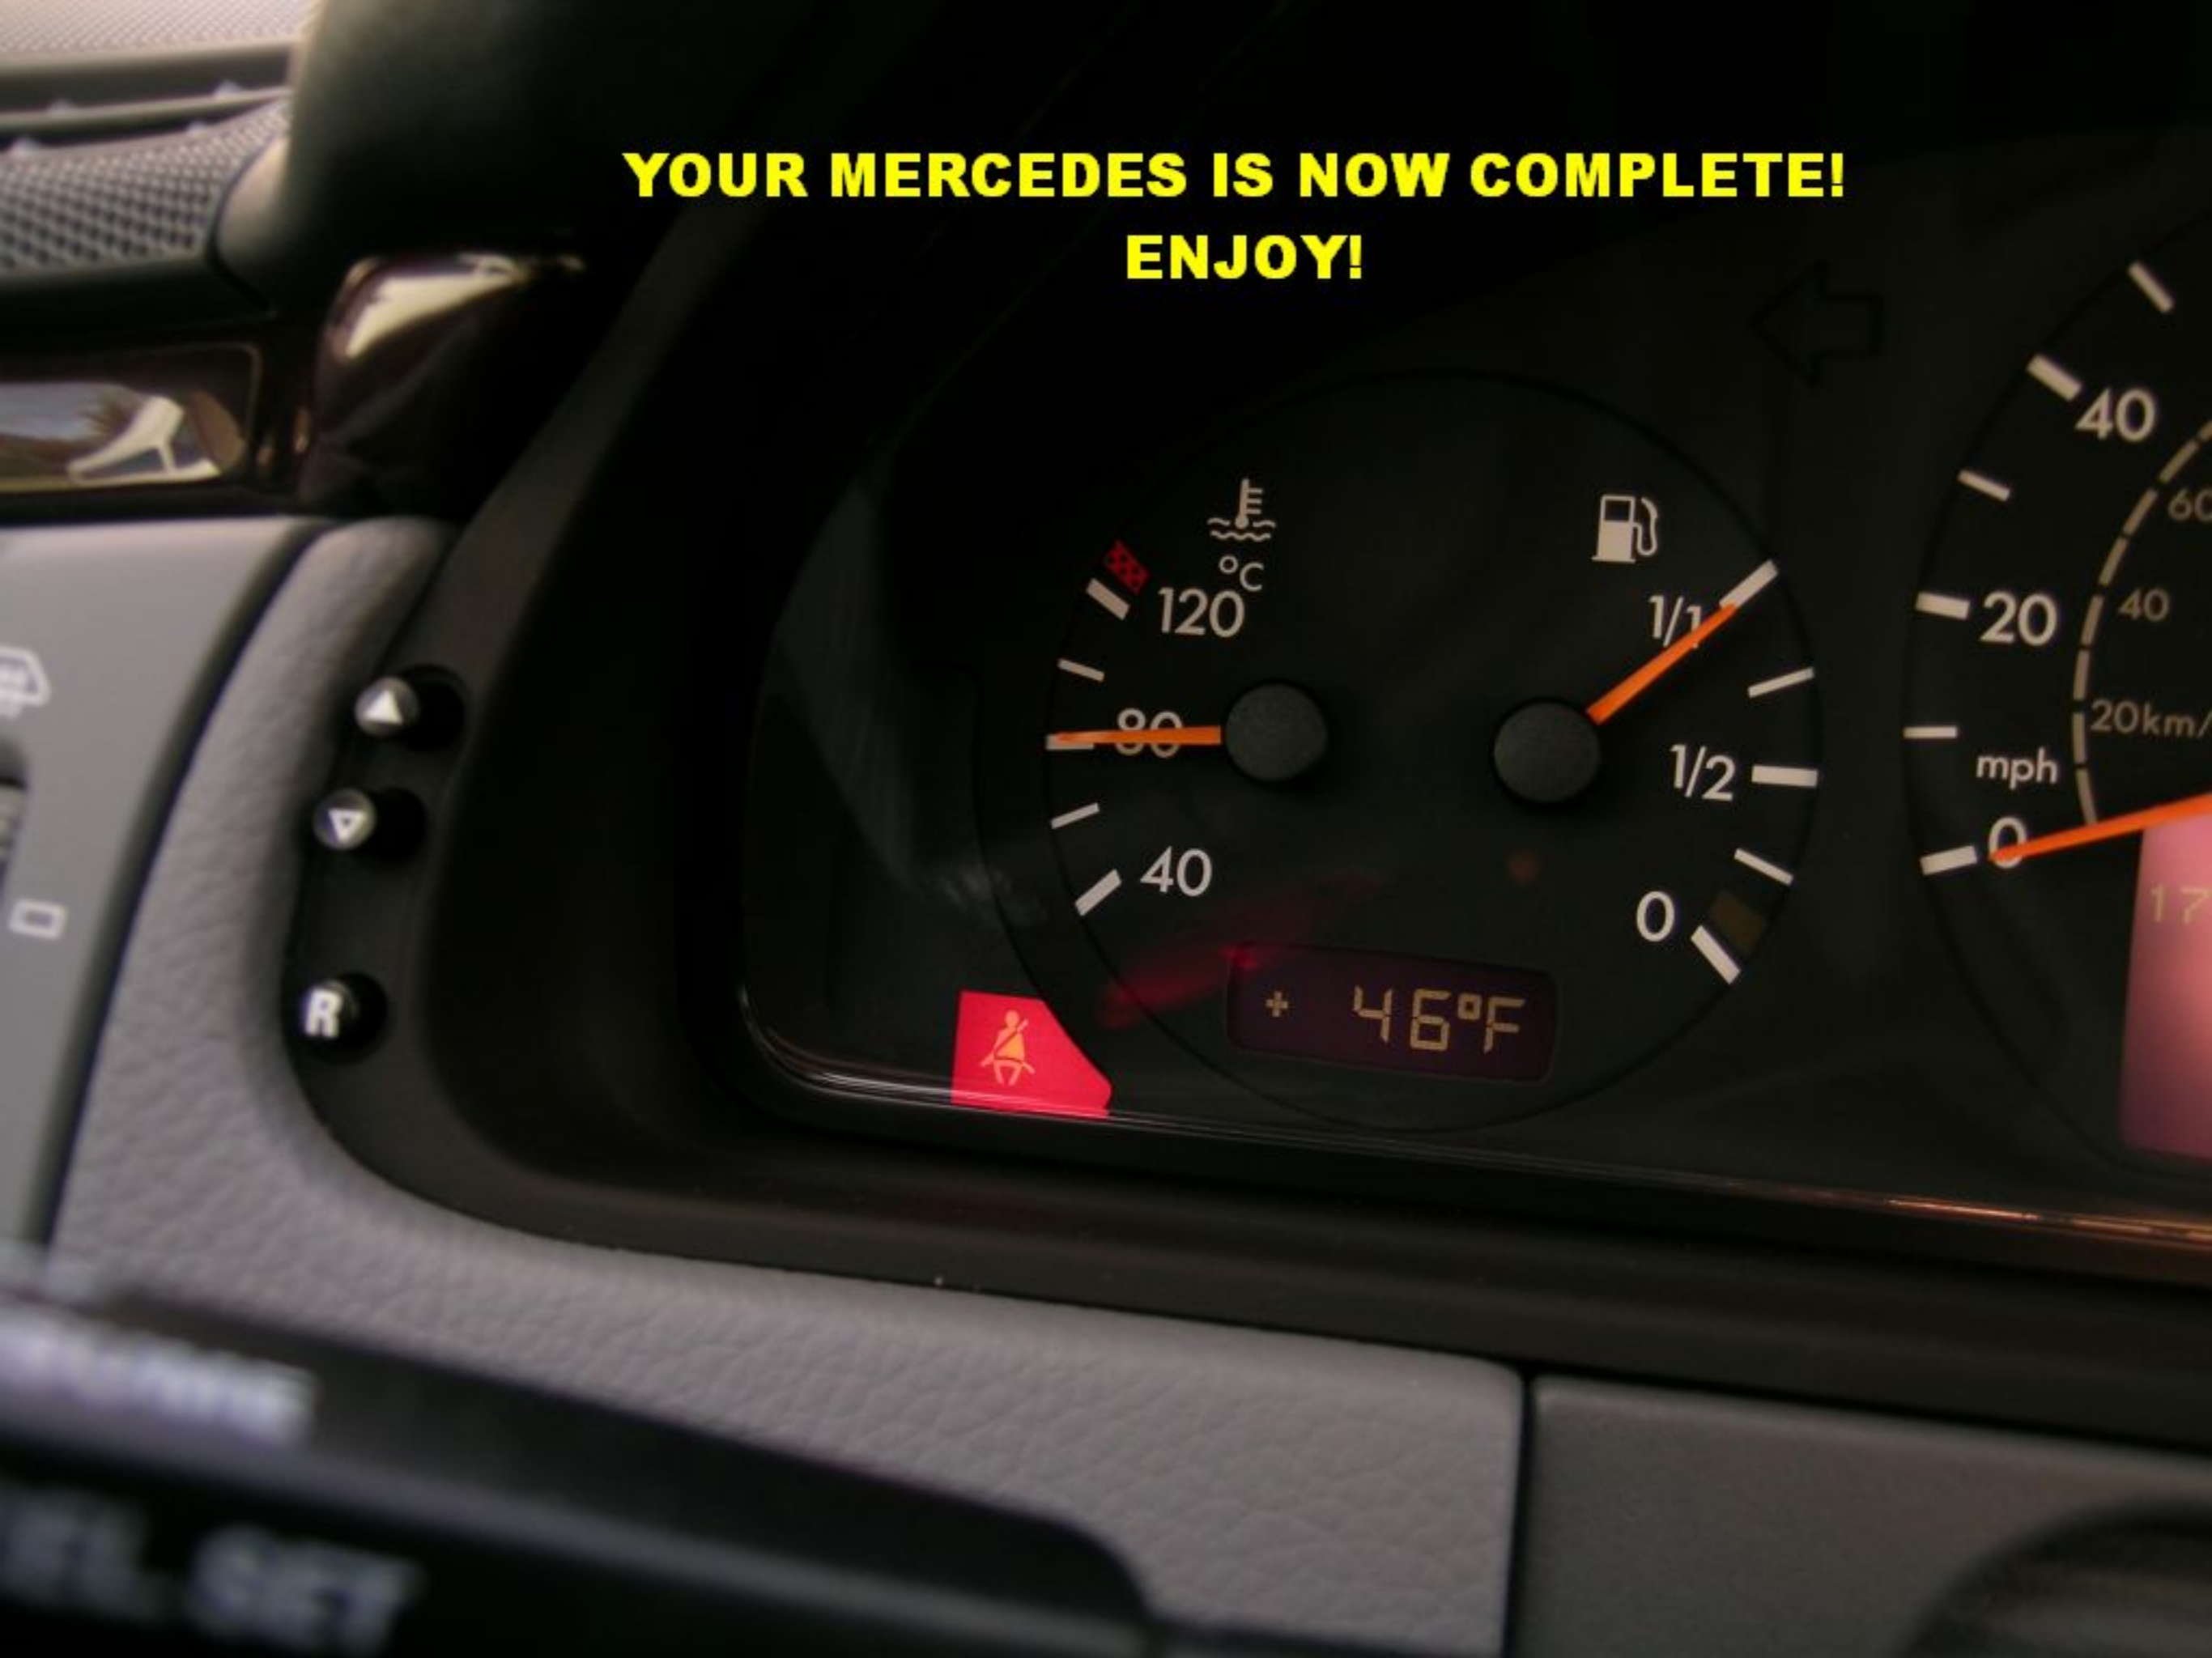
**FOAM BLOCK FITTED TO THE
TEMPERATURE DISPLAY.**
