TECHNICAL INSTRUCTIONS

SAFETY RECALL F0I

EV GATEWAY CONTROL ECM SOFTWARE UPDATE

2012-2014 MY RAV4 EV

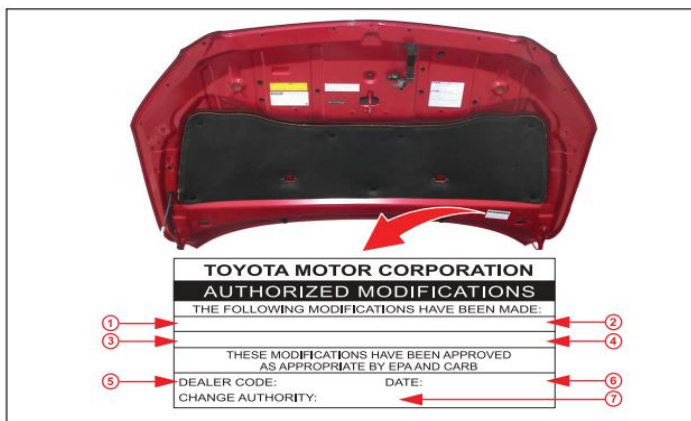
3. Attach the authorized vehicle modification label

- Fill out the label.
- Affix the label to the under-side of the hood.

1	Replacement Power Management Control ECU Part Number
2	New Calibration ID of Power Management Control ECU
3	Dealer Code
4	Date Completed
5	Safety Recall Designation: F0I
